Fire resistance test report

Control joints tested in accordance with AS 1530.4:2014

Test sponsor: HB Fuller Aust Co P/L

Job number: FRT190354

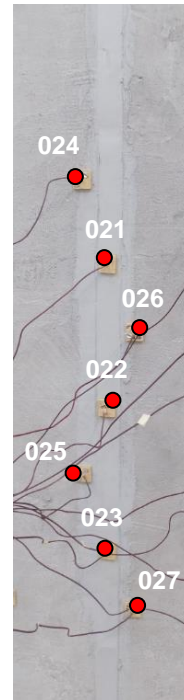
Figure 5 Penetration system B

Control joint	T/C no.	Description
A	011	25 mm from control joint west side, 375 mm up from the centre on the separating element.
	012	25 mm from control joint west side, 125 mm down from the centre on the separating element.
	013	25 mm from control joint east side, 125 mm up from the centre on the separating element.
	014	25 mm from control joint east side, 375 mm down from the centre on the separating element.
B	021	On control joint, 250 mm up from the centre.
	022	On control joint, at the centre.
	023	On control joint, 250 mm down from the centre.
	024	25 mm from control joint west side, 375 mm up from the centre on the separating element.
	025	25 mm from control joint west side, 125 mm down from the centre on the separating element.
	026	25 mm from control joint east side, 125 mm up from the centre on the separating element.
	027	25 mm from control joint east side, 375 mm down from the centre on the separating element.

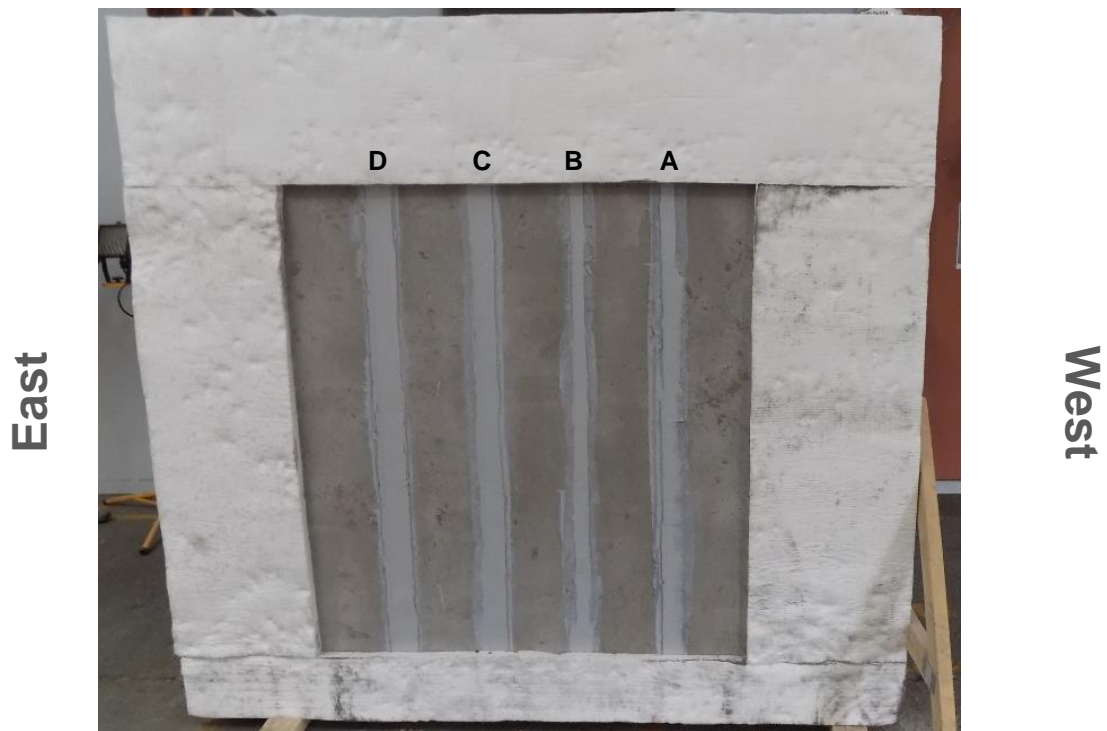
Figure 14 Exposed face of the specimen before the start of the test

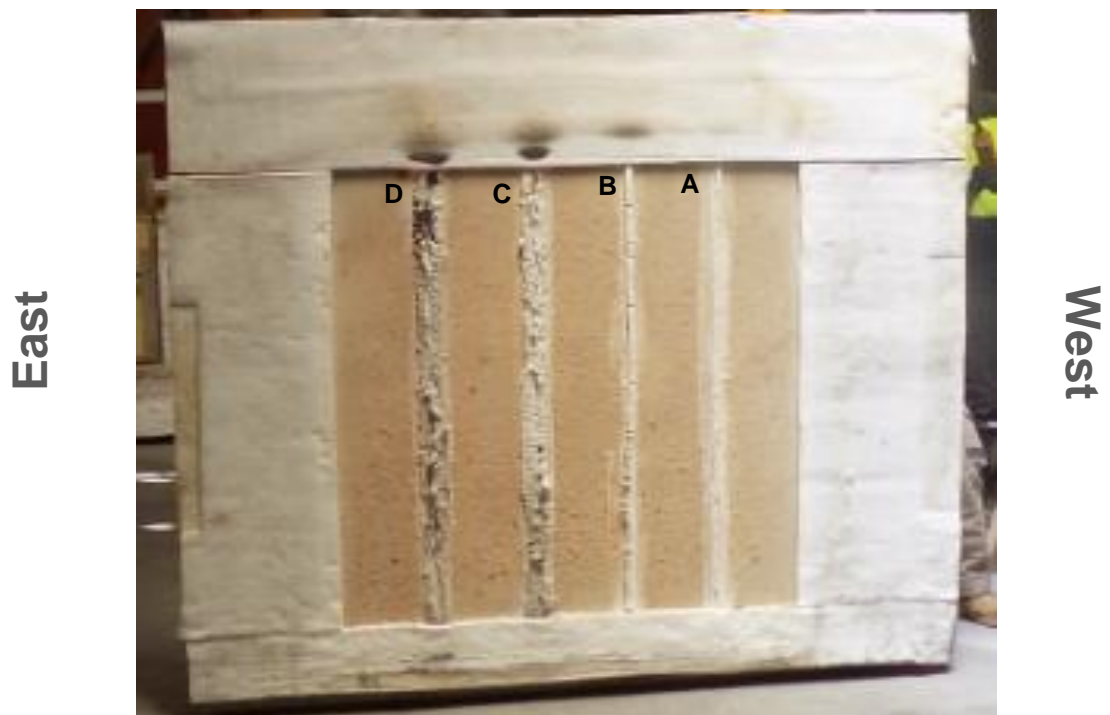
Figure 16 Exposed face of the specimen at the end of the test
