# Fire resistance test report

Test standard: Sections 2 and 10 of AS 1530.4:2014

Product: H.B. Fuller Firesound™ sealant

Job number: FRT220130

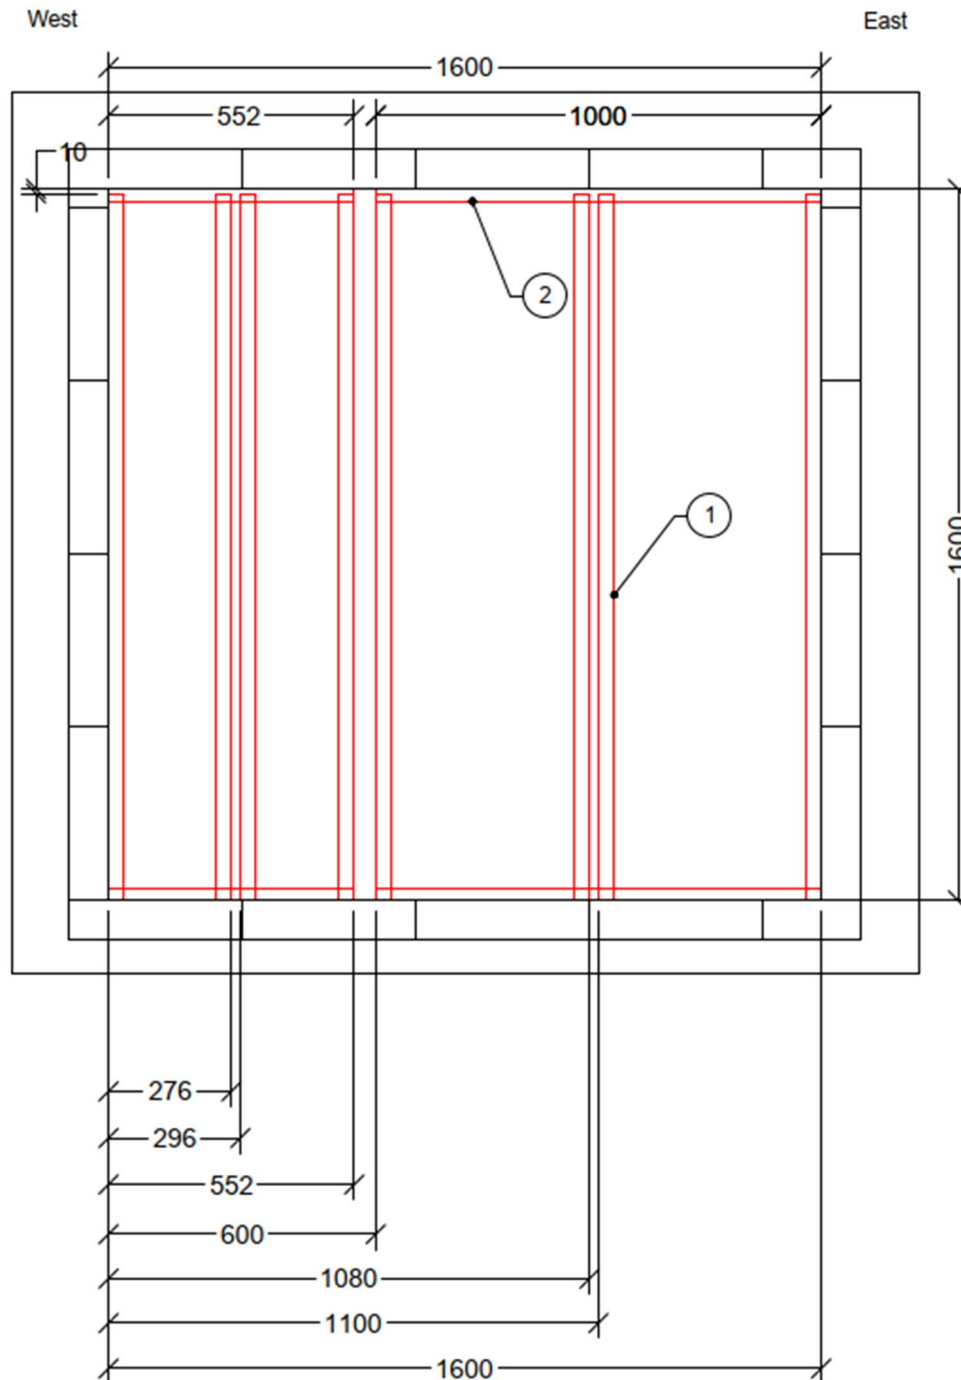
Figure 1 Elevation view of steel framing (unexposed side)

Item	Description	
SE	Overall size	1200 mm wide × 1200 mm high × 142 mm thick (east side) / 116 mm thick (west side)
	Restraint conditions	Restrained on all edges
	Installation	<p>The wall framing comprised of steel framing with studs (item 1) located along the vertical edges and spaced internally to suit the control joints. The head and sill incorporated wall tracks (item 2). The perimeter framing was masonry anchored (item 5) to the test frame blockwork at nominal 300 mm centres horizontal and 200 mm centres vertical, 100 mm in from the bottom corner. Insulation batts (item 11) were installed in the wall framing cavities between the studs.</p> <p>The west side separating element consisted of two 256 mm wide × 1600 mm high steel frame. They were both clad with two layers of 13 mm thick fire rated plasterboard (item 4) on either side of the steel frame.</p> <p>The east side separating element consisted of two 480 mm wide × 1600 mm high steel frame. They were clad with three layers of 13 mm thick fire rated plasterboard (item 4) on either side of the steel frame.</p> <p>Plasterboard sheets in both sections of separating element finished at a nominal 20 mm distance from the top, bottom and both vertical edges. The gaps between the plasterboard and the surround blockwork were sealed with fire rated sealant (item 9)</p> <p>The first layer of fire rated plasterboard sheets was secured to the steel frame with 25 mm plasterboard screws (item 6), the second layer was secured to the steel frame with 40 mm plasterboard screws ((item 7), and the third layer was secured to the steel frame with 50 mm plasterboard screws (item 6) at 200 mm centres on the perimeter edges and 300 mm in the field. Both sections of separating element were separated by three layers of 16 mm thick fire rated plasterboard.</p> <p>See Figure 1 to Figure 12 in Appendix A for more details.</p>

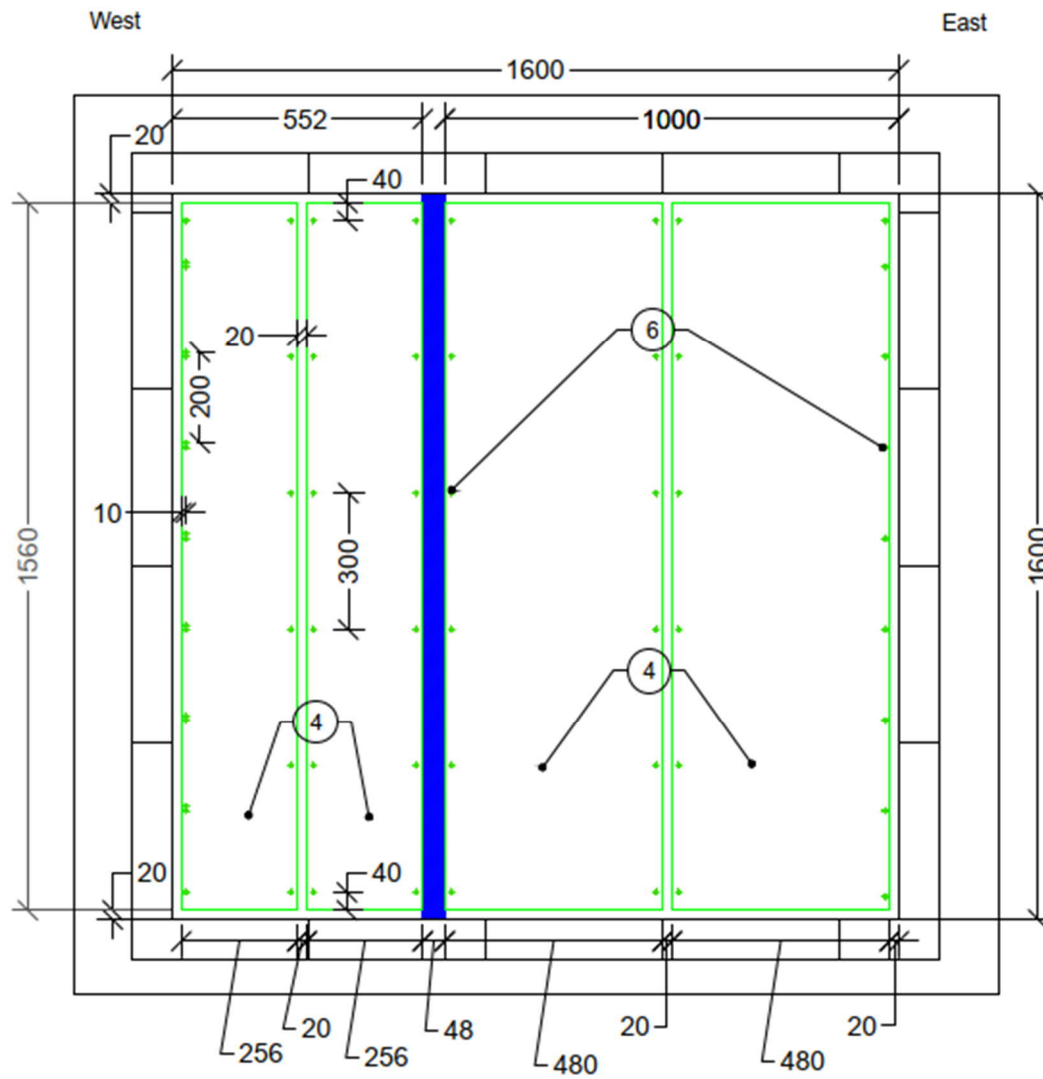
Figure 2 Elevation view of the first layer of plaster board (unexposed side)

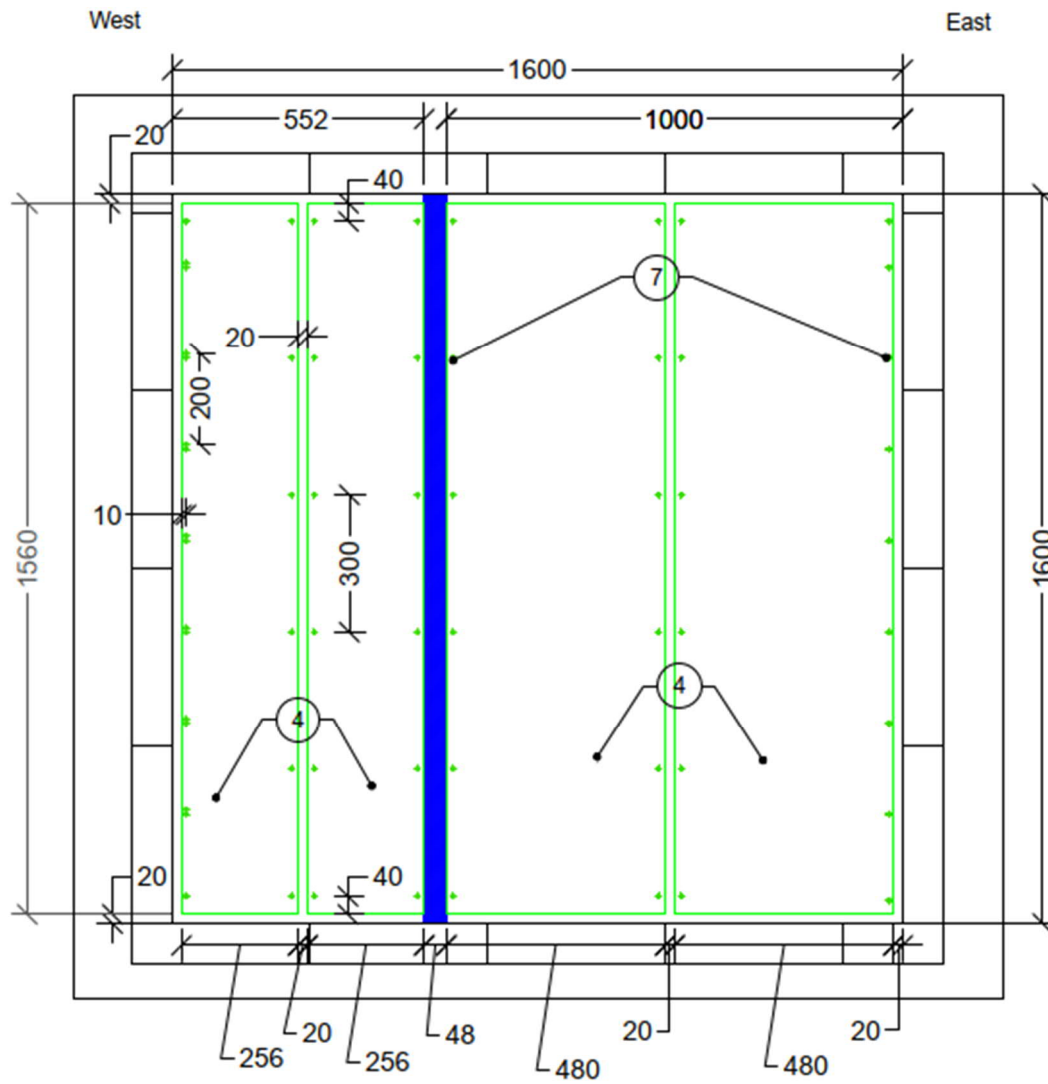
Figure 3 Elevation view of the second layer of plaster board (unexposed side)

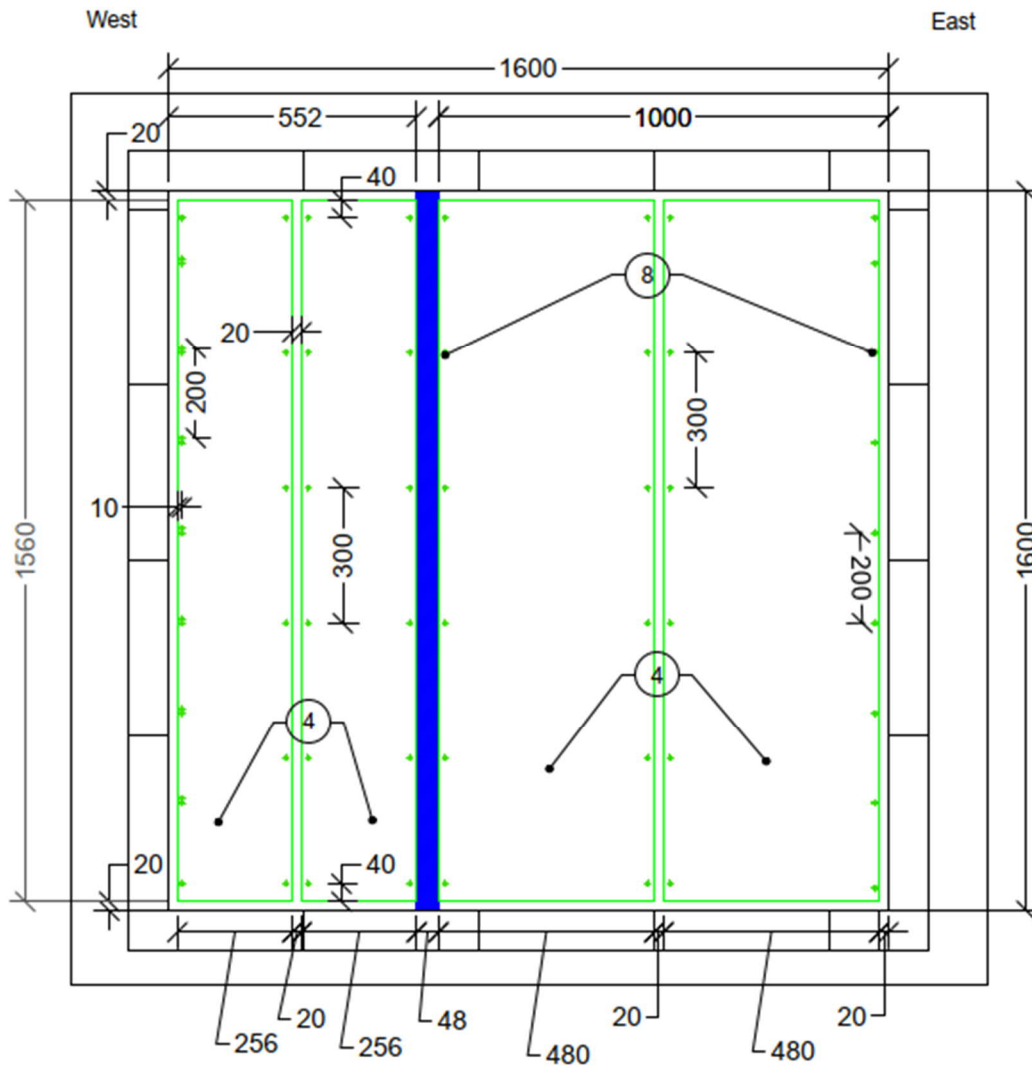
Figure 4 Elevation view of the third layer of plaster board (unexposed side)

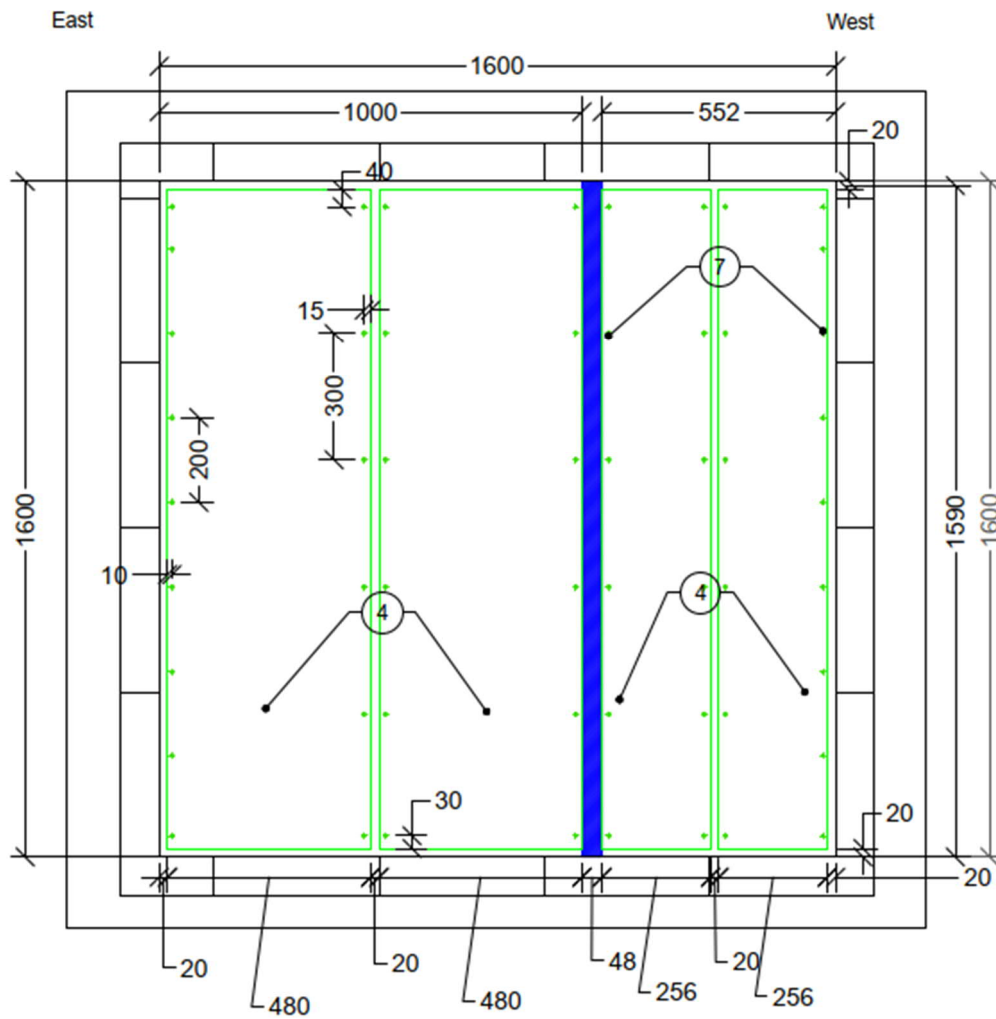
Figure 6 Elevation view of the second layer of plaster board (exposed side)

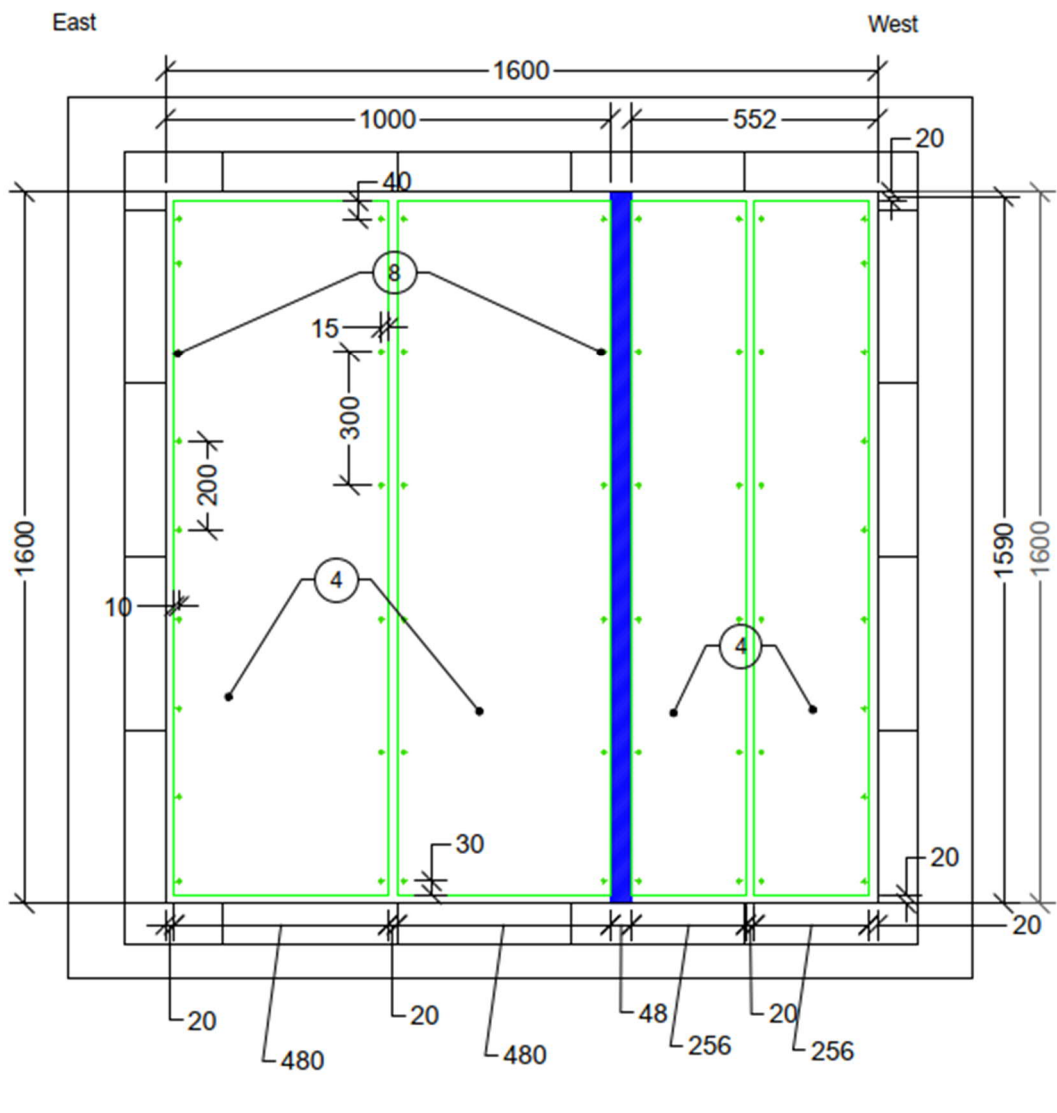
Figure 7 Elevation view of the third layer of plaster board (exposed side)

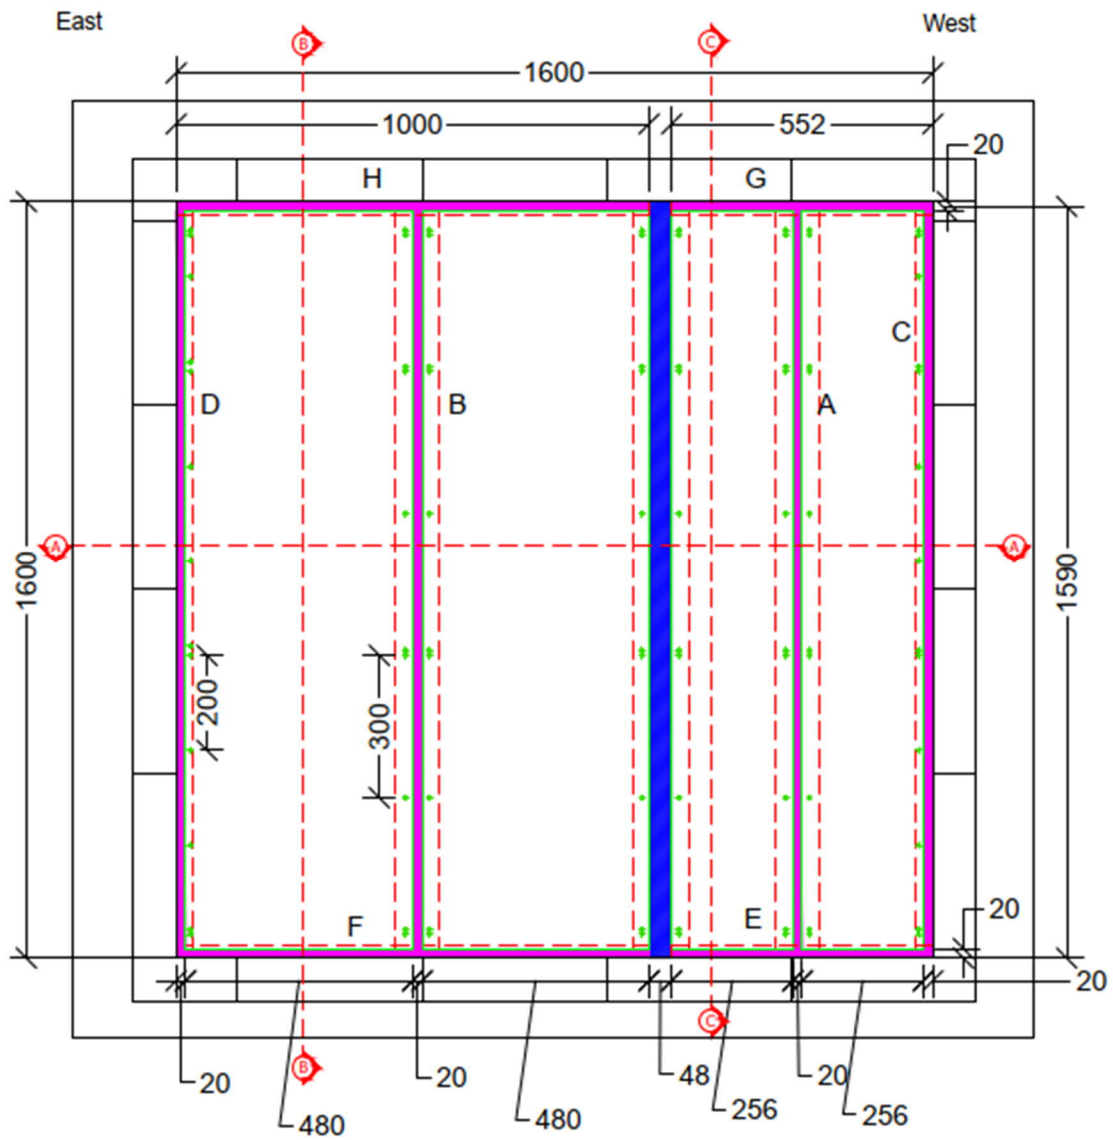
Figure 8 Elevation view of specimen (exposed side)

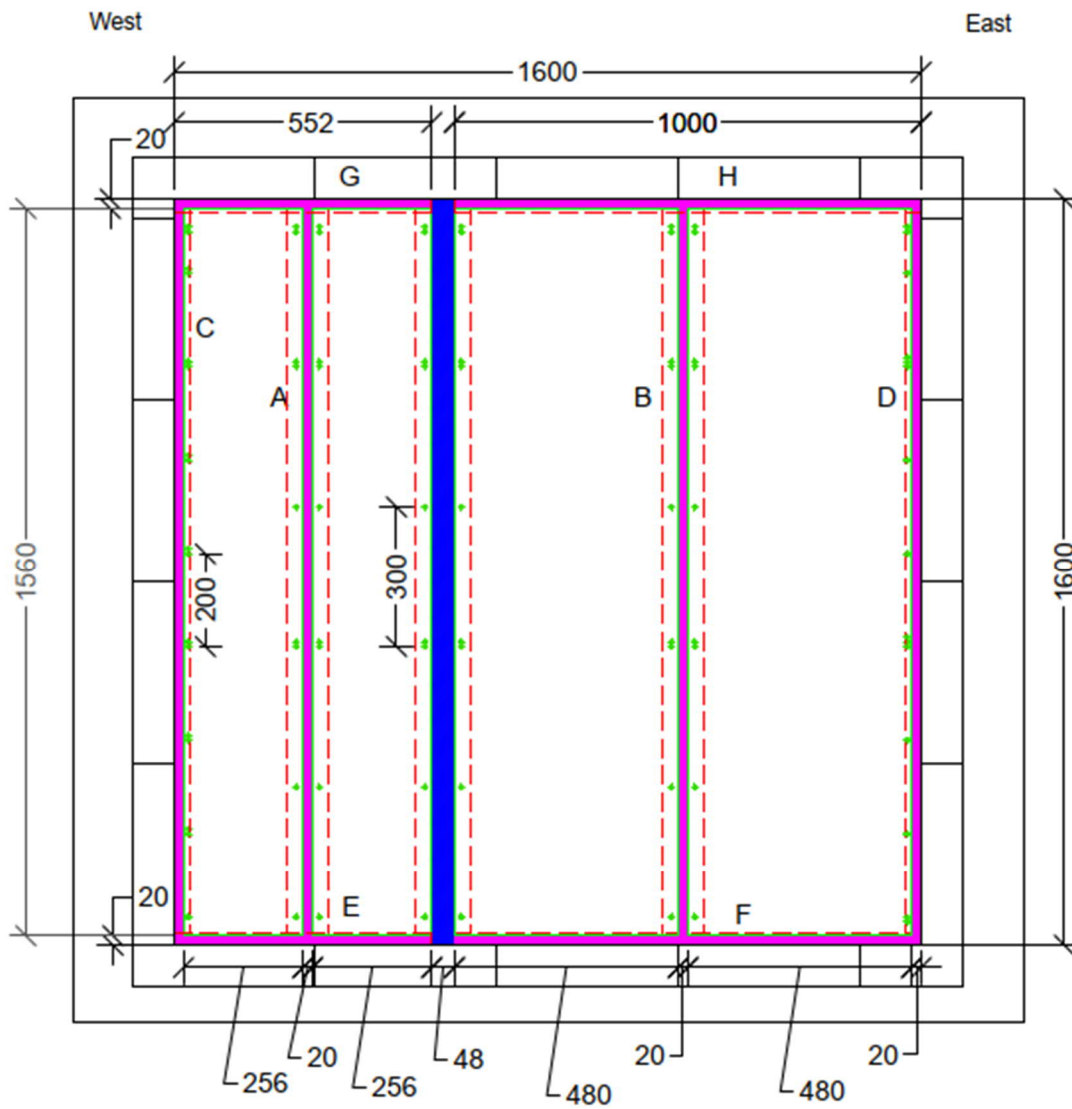
Figure 9 Elevation view of specimen (unexposed side)

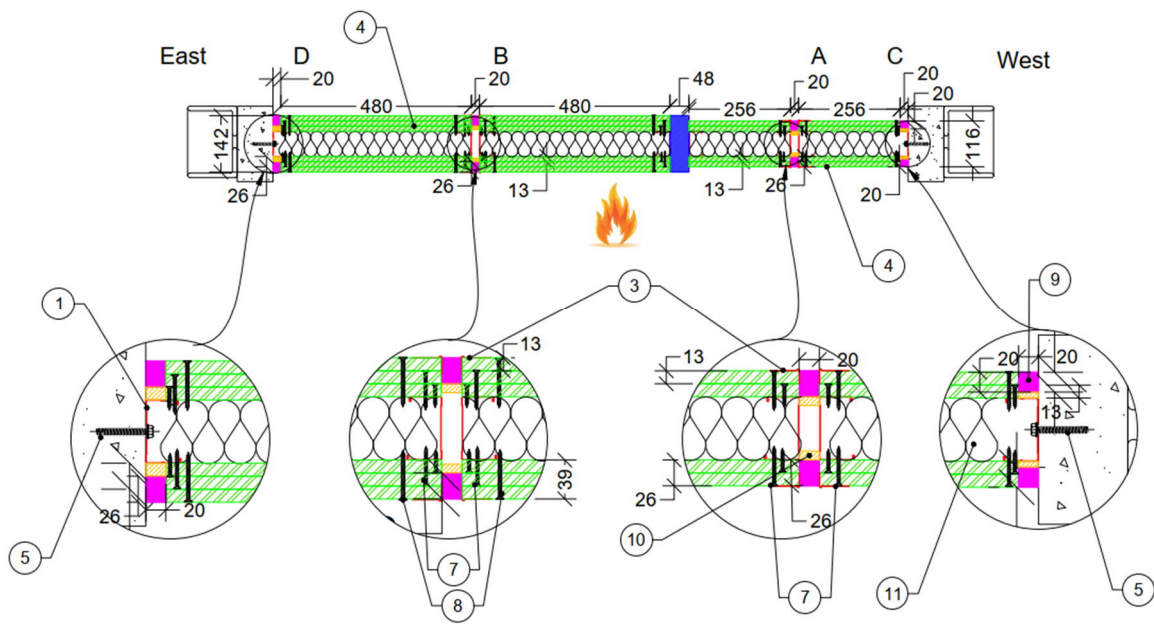
Figure 10 Cross-section A-A

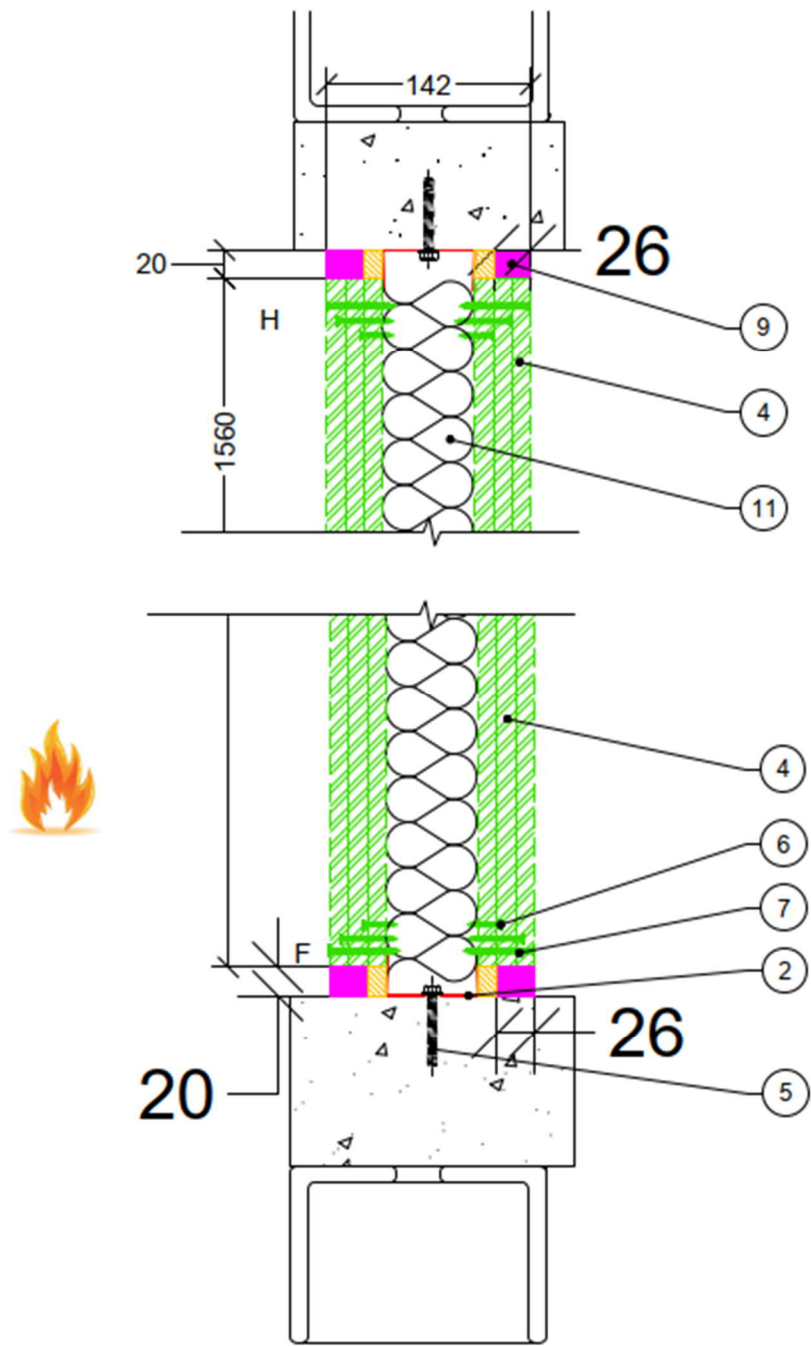
Figure 11 Cross-section B-B

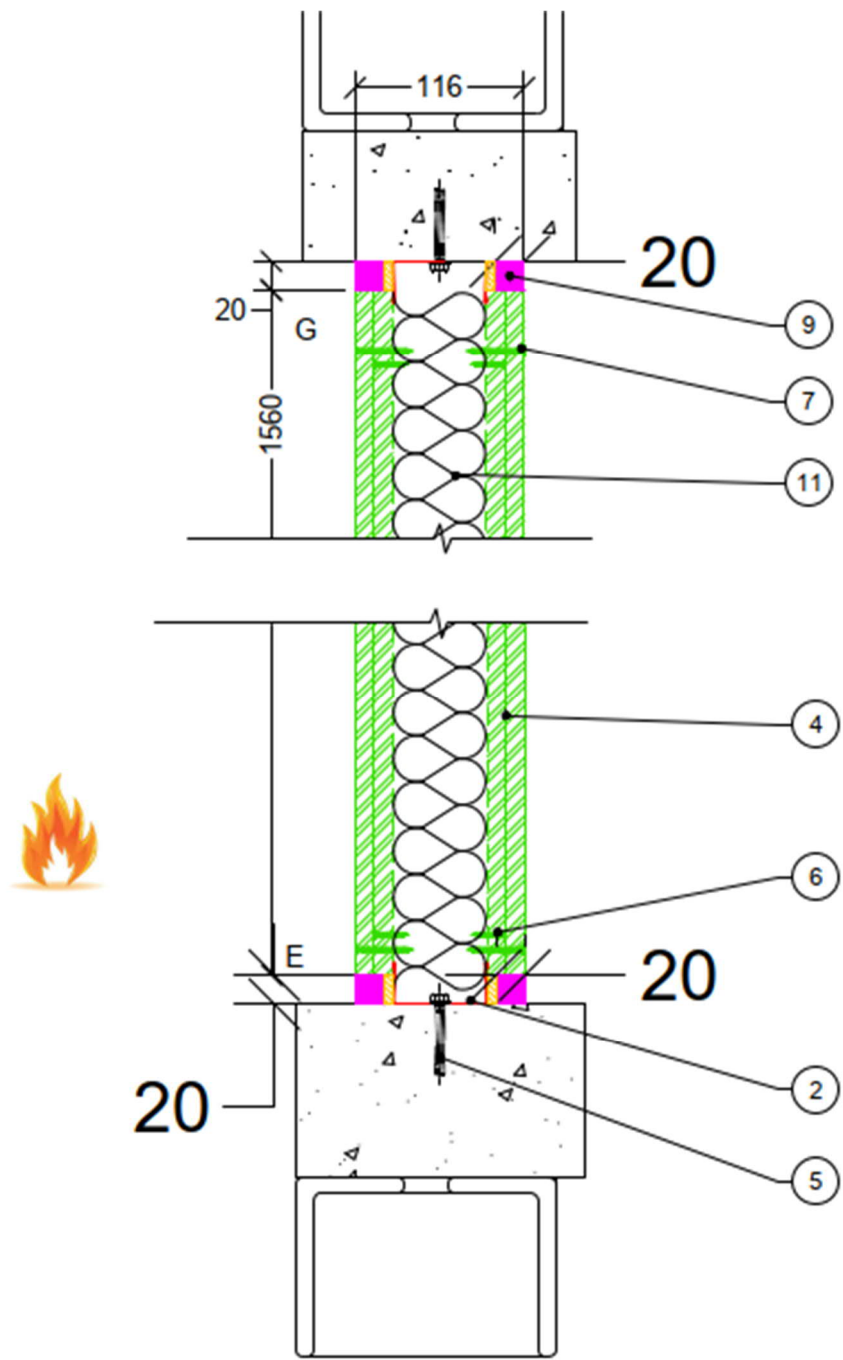
Figure 12 Cross-section C-C

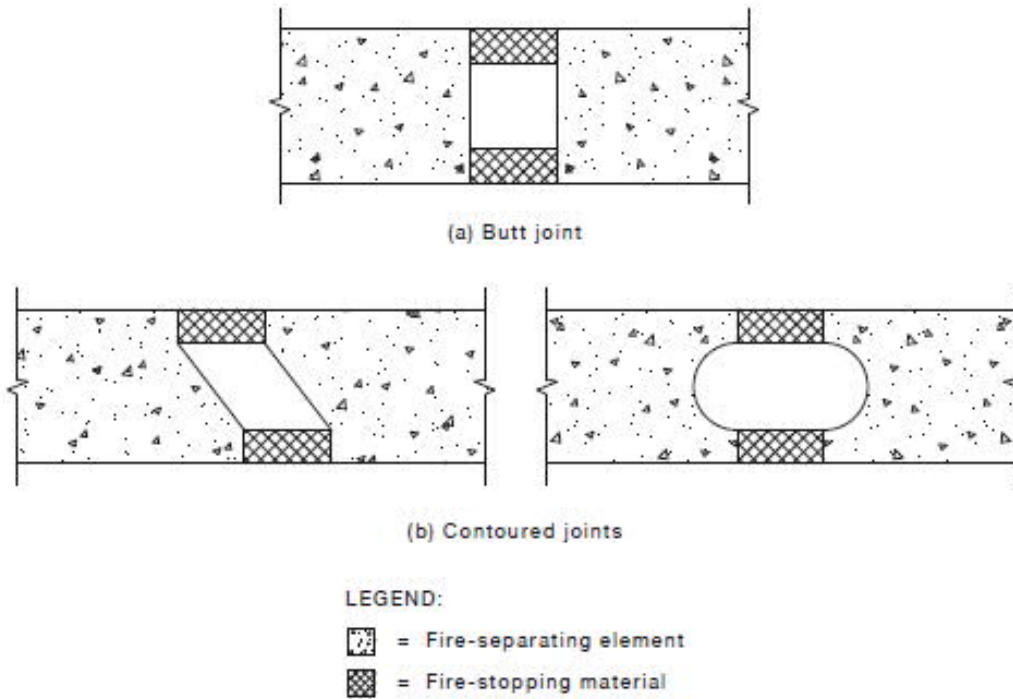
FIGURE 10.12.6 CONTOURED CONTROL JOINTS

- Results obtained from single test on a butt joints may be applied to contoured joints, provided the joints have —
  - equal width and equal or greater depth of sealant; and
  - equal or greater thickness of fire-separating element.
  - Note: Examples of butt and contoured control joints are shown in figure 10.12.6 of AS 1530.4:2014.
- Facings may be applied to the surface of the fire-stopping system.

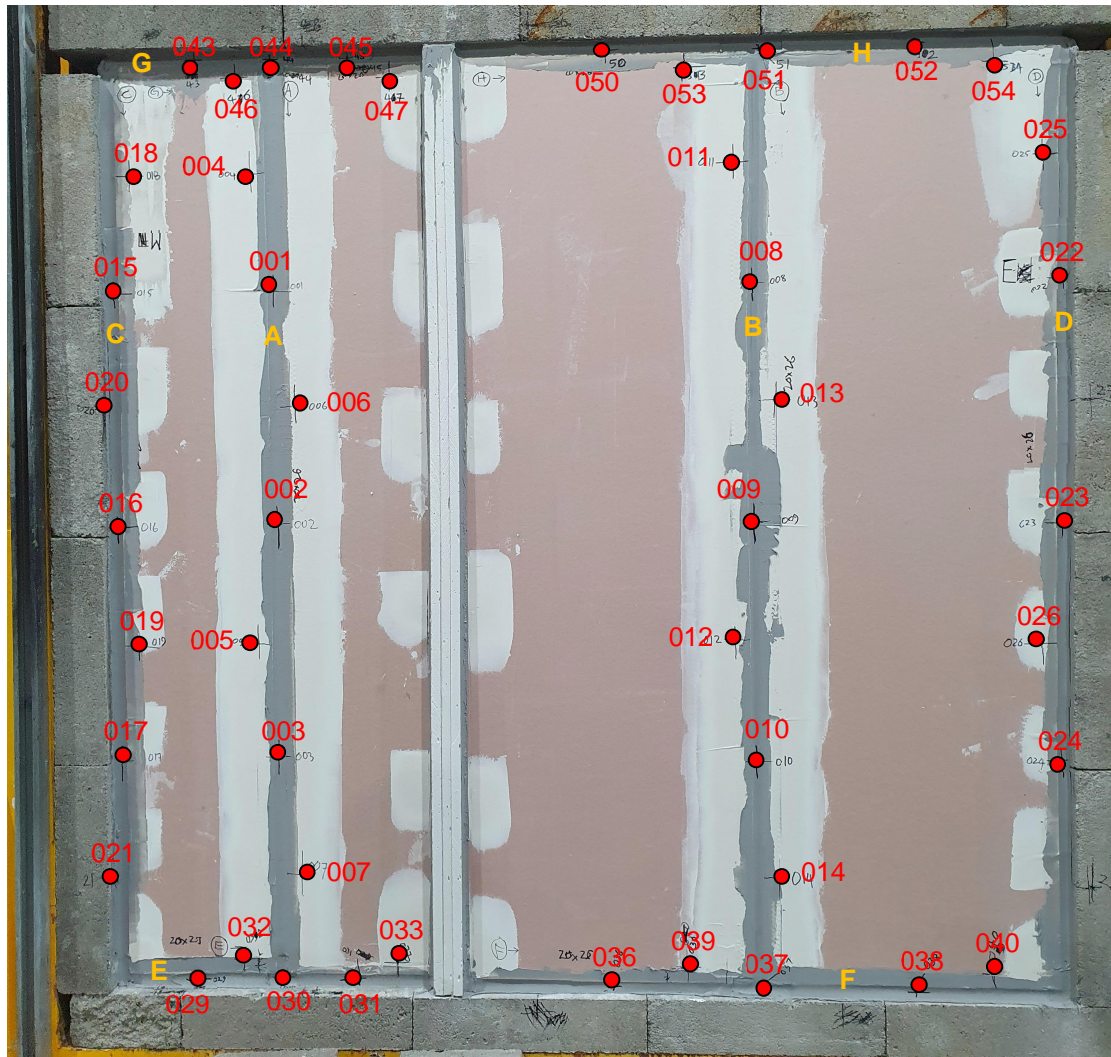
Figure 13 Thermocouple location

Penetration system / control joint	T/C #	Description
A	001	On the control joint, 400 mm up from the centre.
	002	On the control joint, at the centre.
	003	On the control joint, 400 mm down from the centre.
	004	25 mm west from the control joint, 600 mm up from the centre.
	005	25 mm west from the control joint, 200 mm down from the centre.
	006	25 mm east from the control joint, 200 mm up from the centre.
	007	25 mm east from the control joint, 600 mm down from the centre.
B	008	On the control joint, 400 mm up from the centre.
	009	On the control joint, at the centre.
	010	On the control joint, 400 mm down from the centre.
	011	25 mm west from the control joint, 600 mm up from the centre.
	012	25 mm west from the control joint, 200 mm down from the centre.
	013	25 mm east from the control joint, 200 mm up from the centre.
	014	25 mm east from the control joint, 600 mm down from the centre.
C	015	On the control joint, 400 mm up from the centre.

016	On the control joint, at the centre.
	017	On the control joint, 400 mm down from the centre.
	018	25 mm from the control joint, 600 mm up from the centre on the plasterboard.
	019	25 mm from the control joint, 200 mm down from the centre on the plasterboard.
	020	25 mm from the control joint, 200 mm up from the centre on the brick.
	021	25 mm from the control joint, 600 mm down from the centre on the brick.
D	022	On the control joint, 400 mm up from the centre.
	023	On the control joint, at the centre.
	024	On the control joint, 400 mm down from the centre.
	025	25 mm from the control joint, 600 mm up from the centre on the plasterboard.
	026	25 mm from the control joint, 200 mm down from the centre on the plasterboard.
	E	029
030		On the control joint, at the centre. (128 mm)
031		On the control joint, 130 mm east from the centre.
032		25 mm up from the control joint, 60 mm west from the centre on the plasterboard.

033		25 mm up the control joint, 200 mm east from the centre on the plasterboard.
F	036	On the control joint, 250 mm west from the centre.
	037	On the control joint, at the centre. (240 mm)
	038	On the control joint, 250 mm east from the centre.
	039	25 mm up from the control joint, 125 mm west from the centre on the plasterboard.
	040	25 mm up the control joint, 375 mm east from the centre on the plasterboard.
G	043	On the control joint, 130 mm west from the centre.
	044	On the control joint, at the centre.

Penetration system / control joint	T/C #	Description
	045	On the control joint, 130 mm east from the centre.
	046	25 mm down from the control joint, 60 mm west from the centre on the plasterboard.
	047	25 mm down the control joint, 200 mm east from the centre on the plasterboard.
H	050	On the control joint, 250 mm west from the centre.
	051	On the control joint, at the centre.
	052	On the control joint, 250 mm east from the centre.
	053	25 mm down from the control joint, 125 mm west from the centre on the plasterboard.
	054	25 mm down from the control joint, 375 mm east from the centre on the plasterboard.

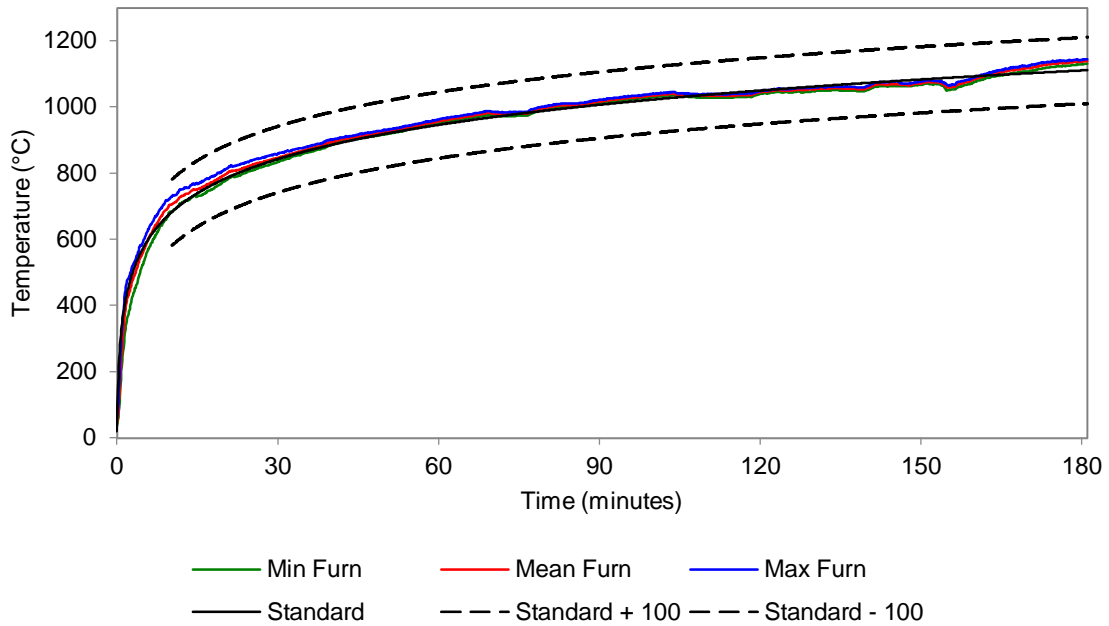
Figure 14 Furnace thermocouple temperature vs time

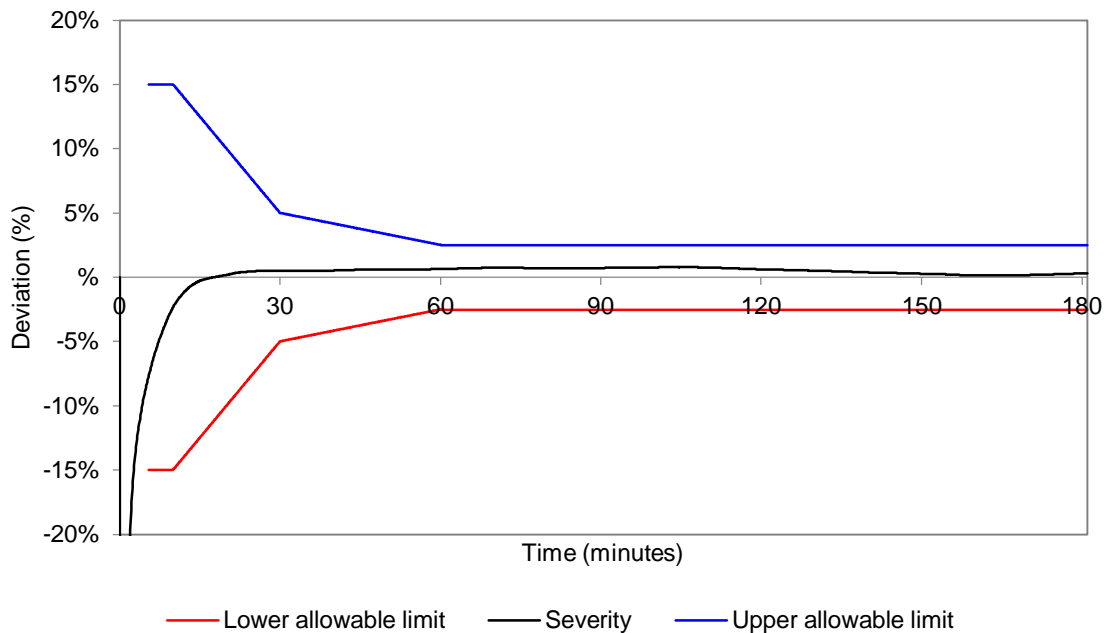
Figure 15 Percentage deviation of exposure severity vs time

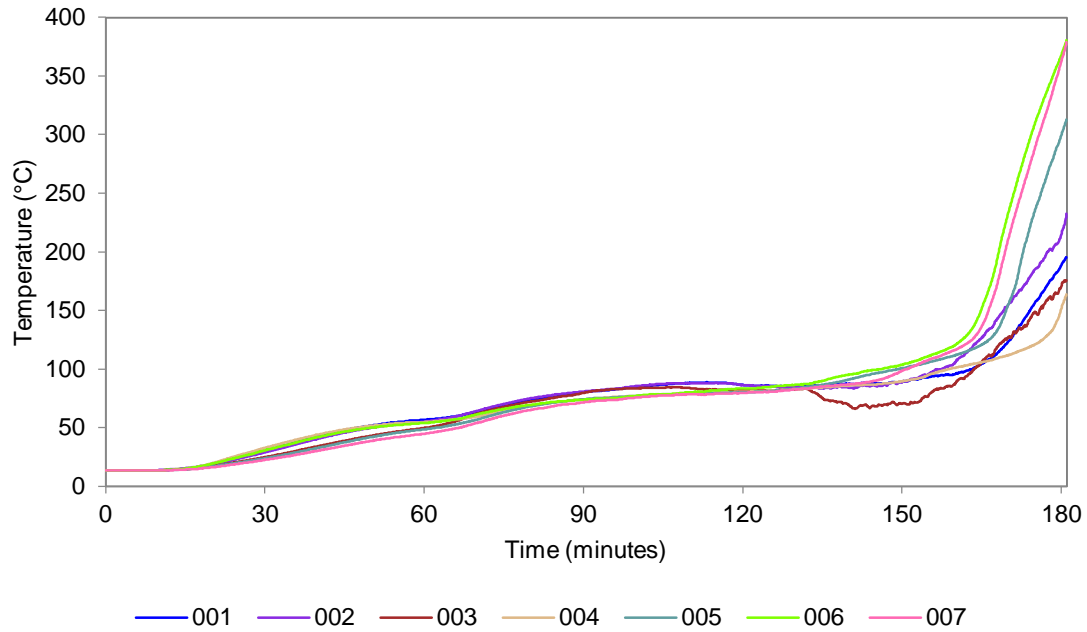
Figure 16 Control joint A – temperature vs time

Time		Observation
Min	Sec	
<b>Penetration system A</b>		
00	00	The fire resistance test started. The initial temperature of the test specimen was approximately 14 °C
15	00	The test specimen continued to maintain integrity and insulation in accordance with AS 1530.4:2014.
30	00	The test specimen continued to maintain integrity and insulation in accordance with AS 1530.4:2014.
45	00	The test specimen continued to maintain integrity and insulation in accordance with AS 1530.4:2014.
56	50	A crack occurred in the control joint near TC003
60	00	The test specimen continued to maintain integrity and insulation in accordance with AS 1530.4:2014.
90	00	The test specimen continued to maintain integrity and insulation in accordance with AS 1530.4:2014.
120	00	The test specimen continued to maintain integrity and insulation in accordance with AS 1530.4:2014.
168	00	<b>TC006 on the separating element recorded a temperature of 194 °C. Failure of insulation in accordance with clause 2.13.3(b) of AS 1530.4:2014, where the maximum temperature of thermocouple TC006 exceeded the initial temperature by more than 180 K.</b>

Control joint	T/C #	Description <sup>1</sup>	Temp (°C) at t (minutes)					Limit <sup>2</sup> (minutes)
			t=0	t=60	t=90	t=120	t=180	
A	001	On the control joint	14	56	80	86	188	180
	002	On the control joint	14	55	81	86	214	176
	003	On the control joint	14	50	80	82	170	-
	004	25 mm from the control joint	14	55	74	80	151	-
	005	25 mm from the control joint	14	48	74	80	299	172
	006	25 mm from the control joint	14	54	74	83	368	167
	007	25 mm from the control joint	14	45	72	79	362	169
B	008	On the control joint	13	46	58	68	92	-
	009	On the control joint	13	44	56	65	88	-
	010	On the control joint	14	43	55	62	84	-
	011	25 mm from the control joint	14	41	51	59	76	-
	012	25 mm from the control joint	14	40	53	63	83	-
	013	25 mm from the control joint	14	46	57	64	89	-
	014	25 mm from the control joint	14	37	54	62	85	-
C	015	On the control joint	13	48	84	87	230	174
	016	On the control joint	13	44	75	85	254	171
	017	On the control joint	13	32	69	77	218	176

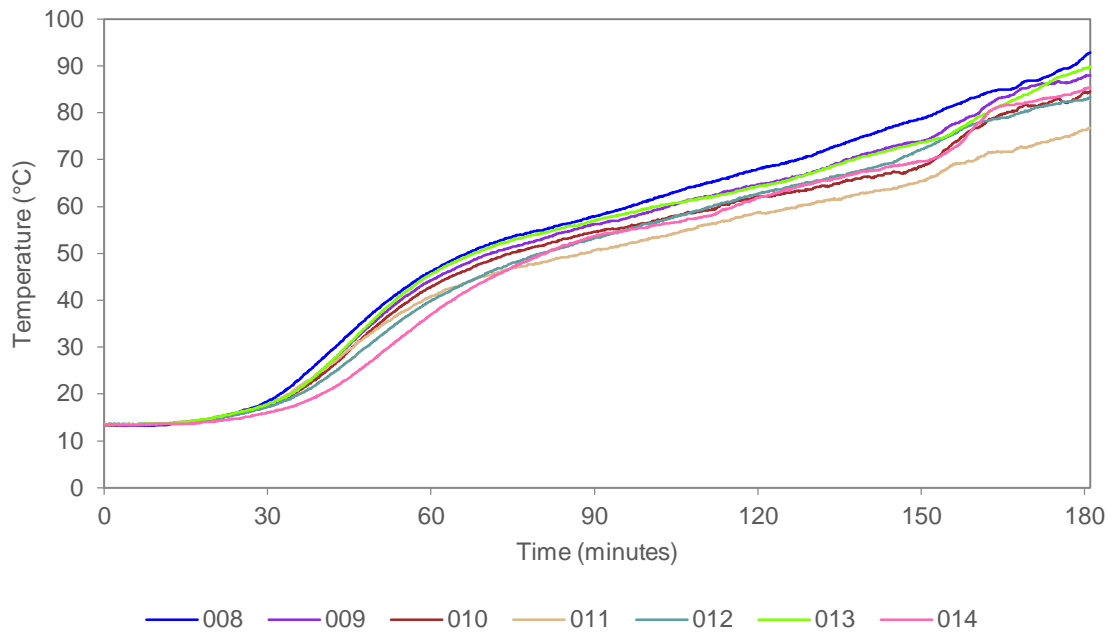
Figure 17 Control joint B – temperature vs time

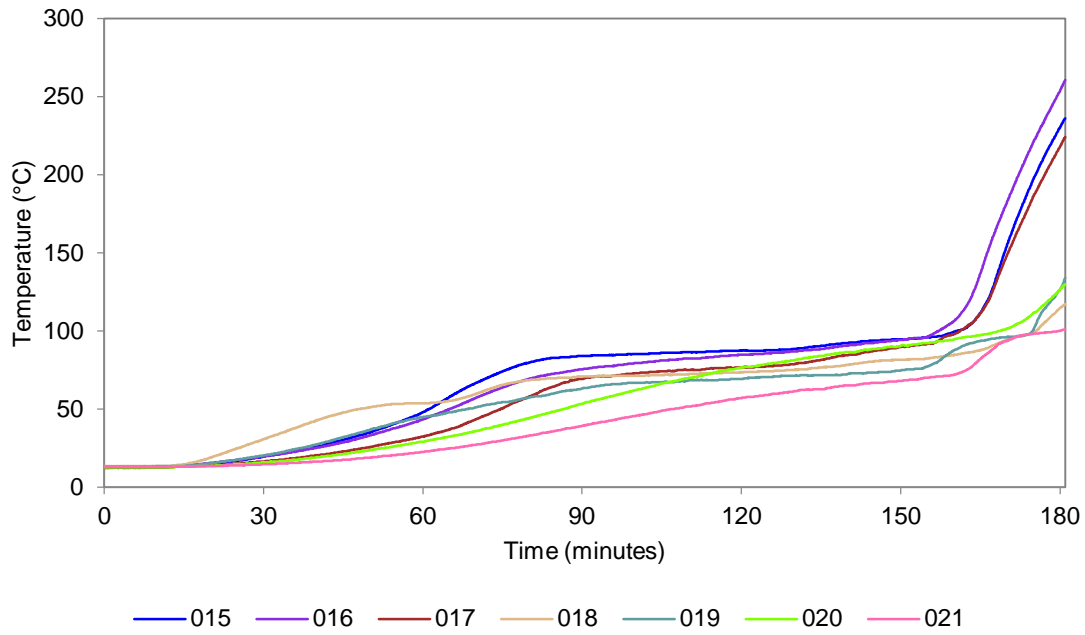
Figure 18 Control joint C – temperature vs time

Time		Observation
Min	Sec	
<b>Penetration system C</b>		
00	00	The fire resistance test started. The initial temperature of the test specimen was approximately 14 °C
15	00	The test specimen continued to maintain integrity and insulation in accordance with AS 1530.4:2014.
30	00	The test specimen continued to maintain integrity and insulation in accordance with AS 1530.4:2014.
45	00	The test specimen continued to maintain integrity and insulation in accordance with AS 1530.4:2014.
60	00	The test specimen continued to maintain integrity and insulation in accordance with AS 1530.4:2014.
90	00	The test specimen continued to maintain integrity and insulation in accordance with AS 1530.4:2014.
120	00	The test specimen continued to maintain integrity and insulation in accordance with AS 1530.4:2014.
171	30	<b>TC016 on the separating element recorded a temperature of 194 °C. Failure of insulation in accordance with clause 2.13.3(b) of AS 1530.4:2014, where the maximum temperature of thermocouple TC016 exceeded the initial temperature by more than 180 K.</b>

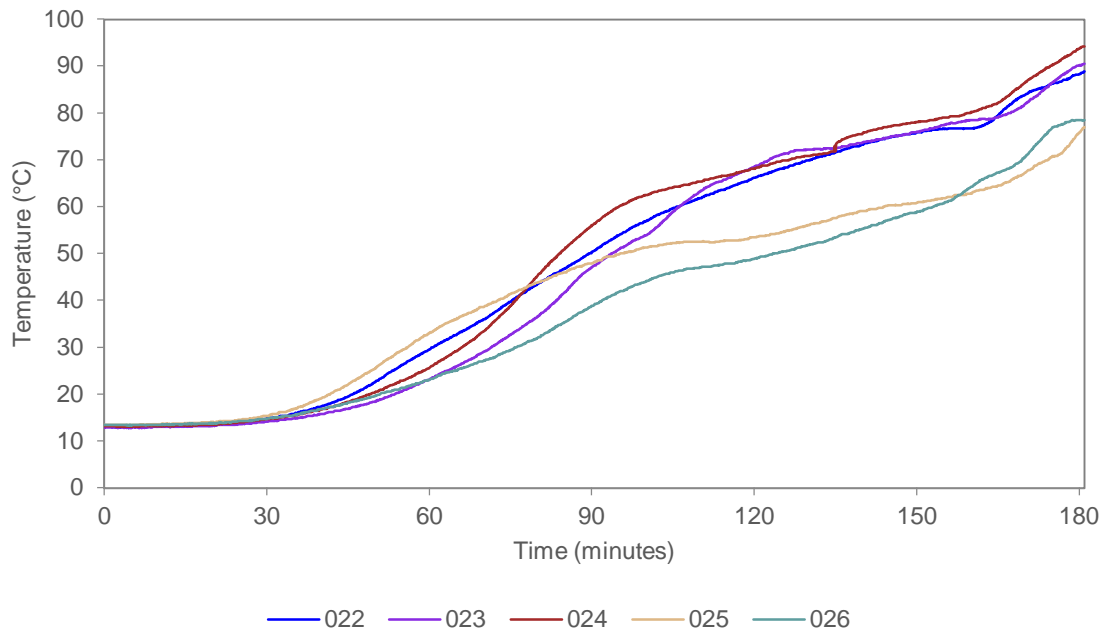
Figure 19 Control joint D – temperature vs time

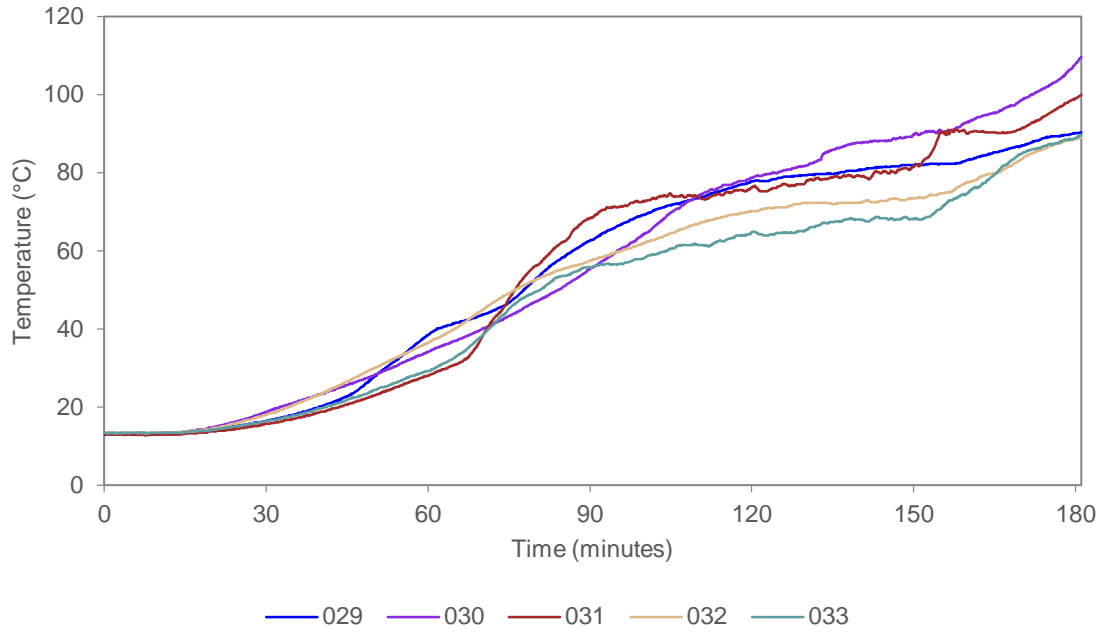
Figure 20 Control joint E – temperature vs time

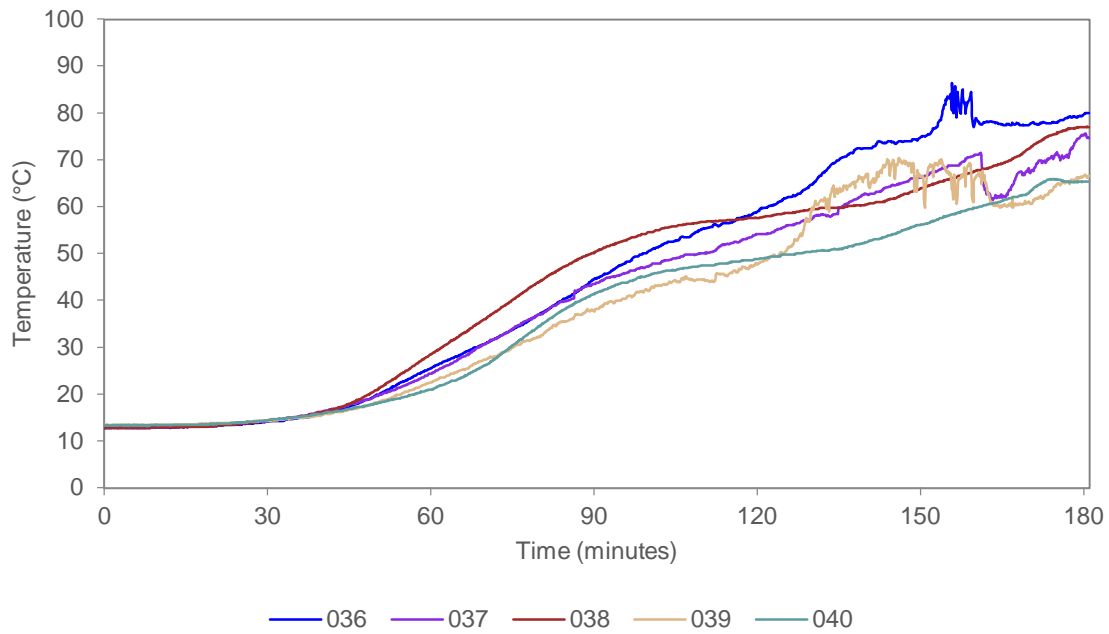
Figure 21 Control joint F – temperature vs time
