# Fire resistance test report

Test standard: Sections 2 and 10 of AS 1530.4:2014

Product: H.B. Fuller Firesound™ sealant

Job number: FRT220130

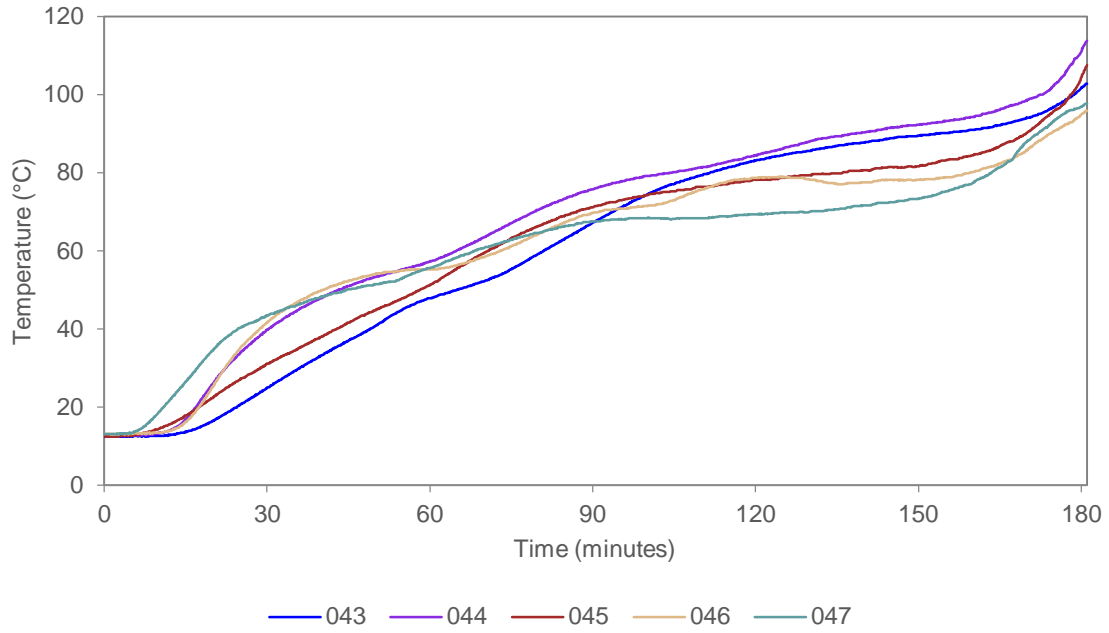
Figure 22 Control joint G – temperature vs time

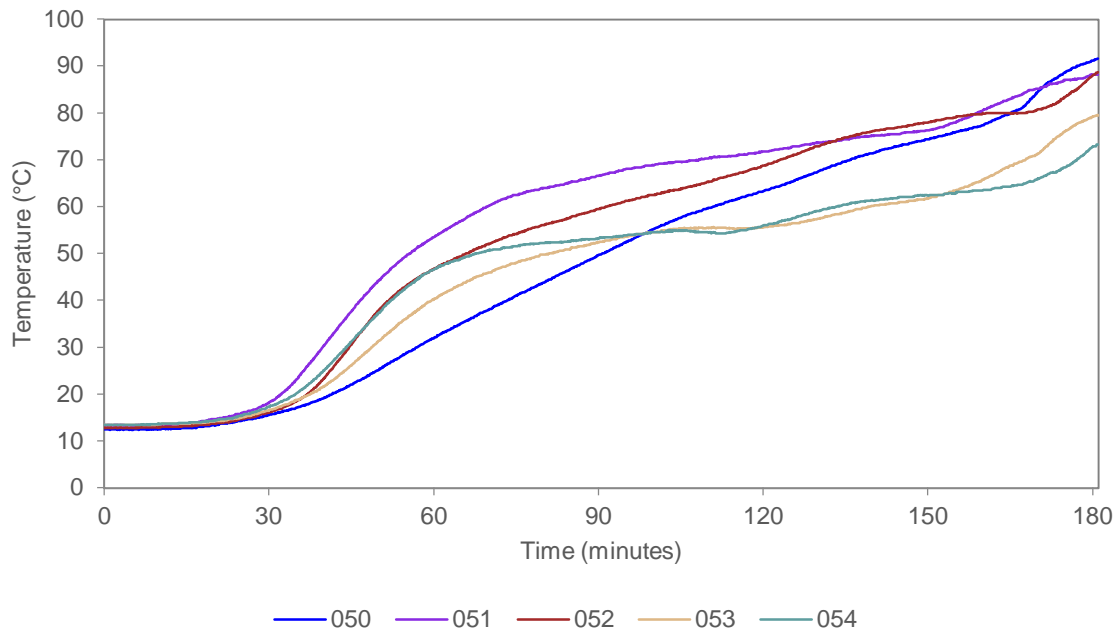
Figure 23 Control joint H – temperature vs time

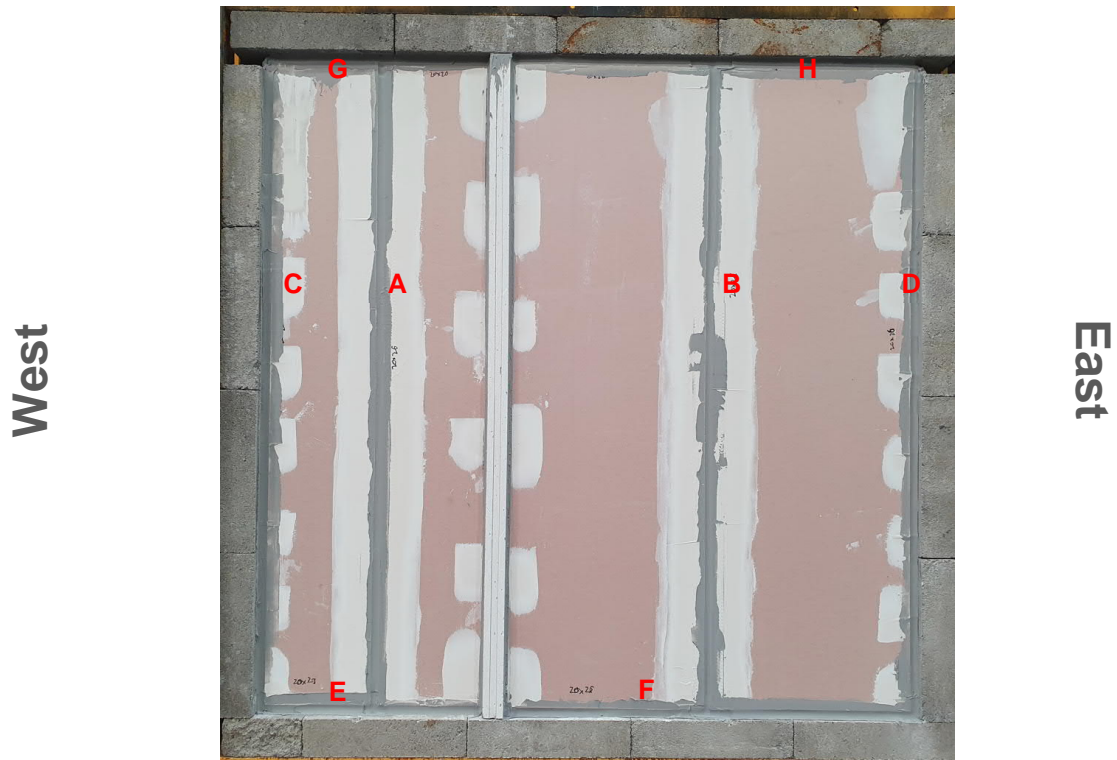
Figure 24 Unexposed face of the specimen before the start of the test

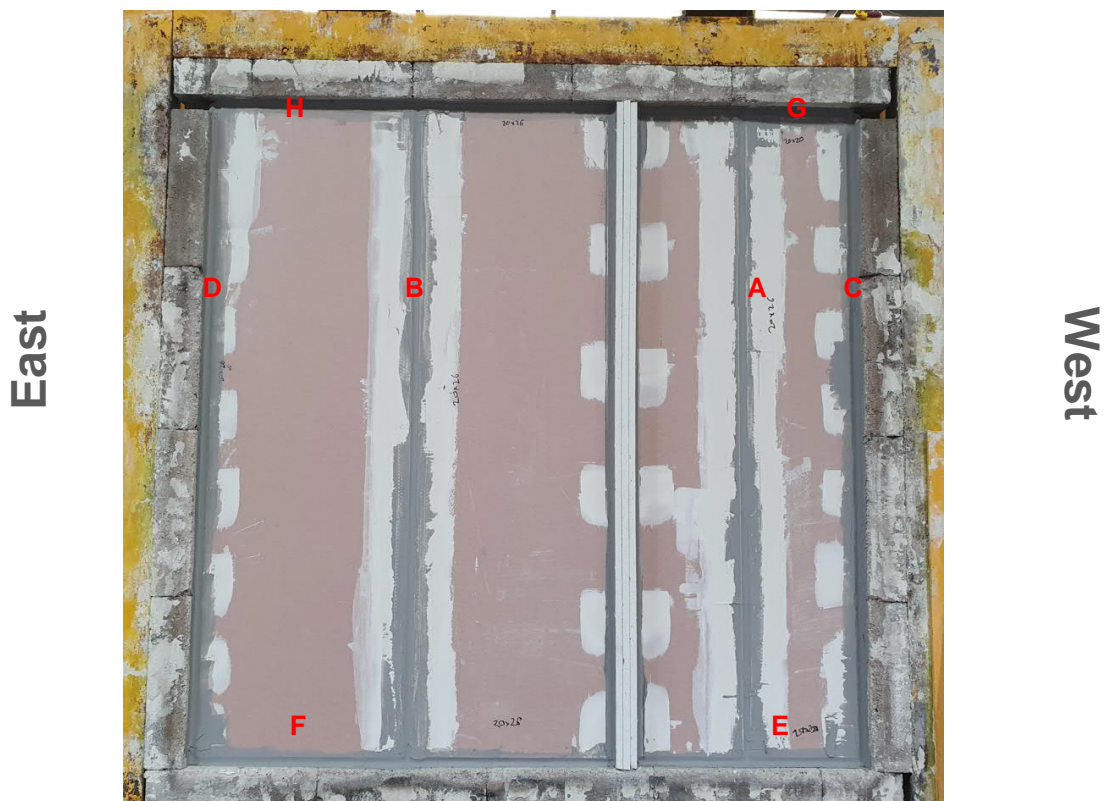
Figure 25 Exposed face of the specimen before the start of the test

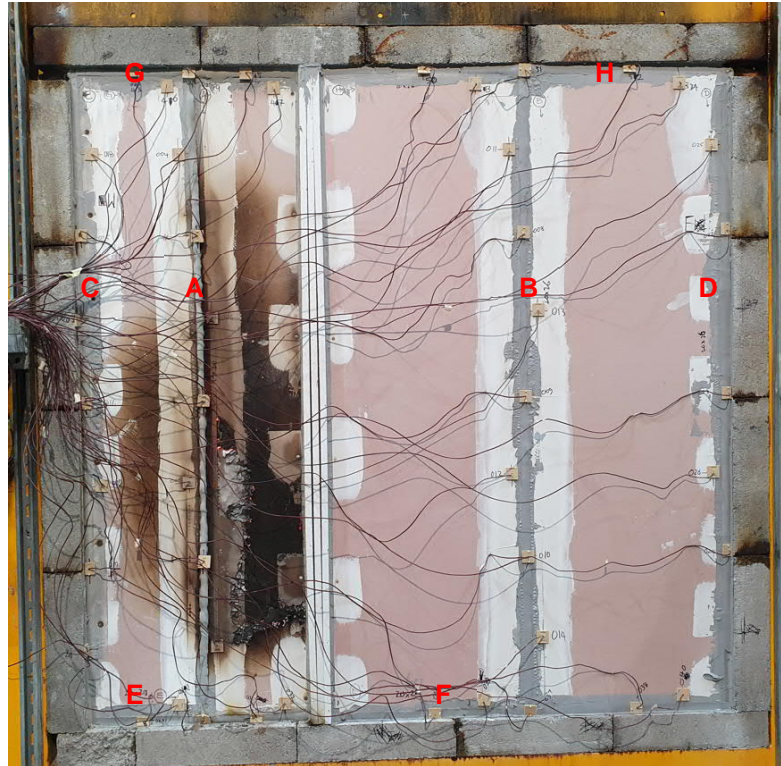
Figure 26 Unexposed face of the specimen at the end of the test

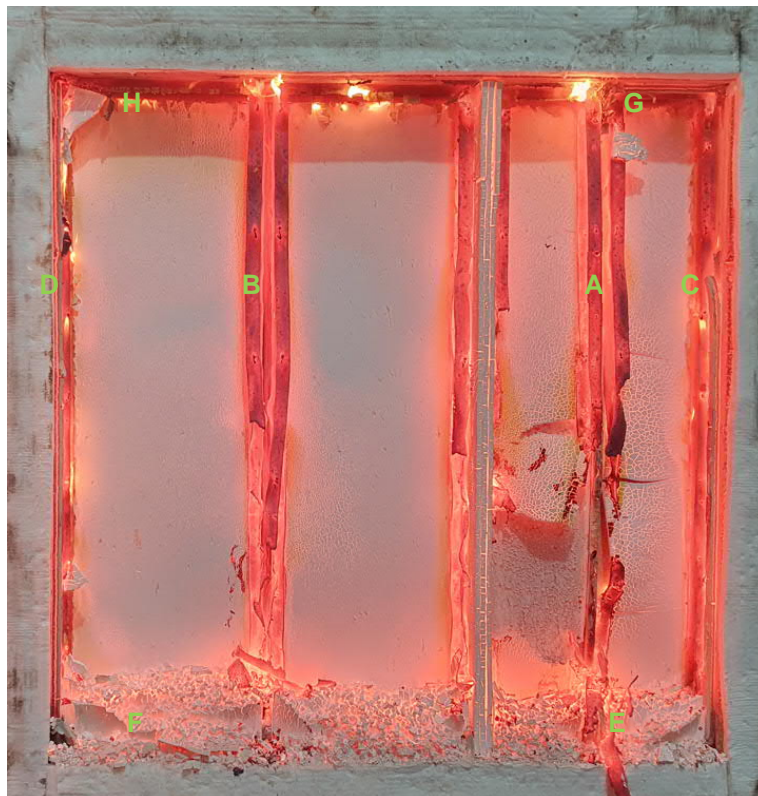
Figure 27 Exposed face of the specimen at the end of the test
