Fire resistance test report

Test standard: Sections 2 and 10 of AS 1530.4:2014

Test sponsor: H B Fuller Aus Co P/L; USG Boral

Job number: 48763900

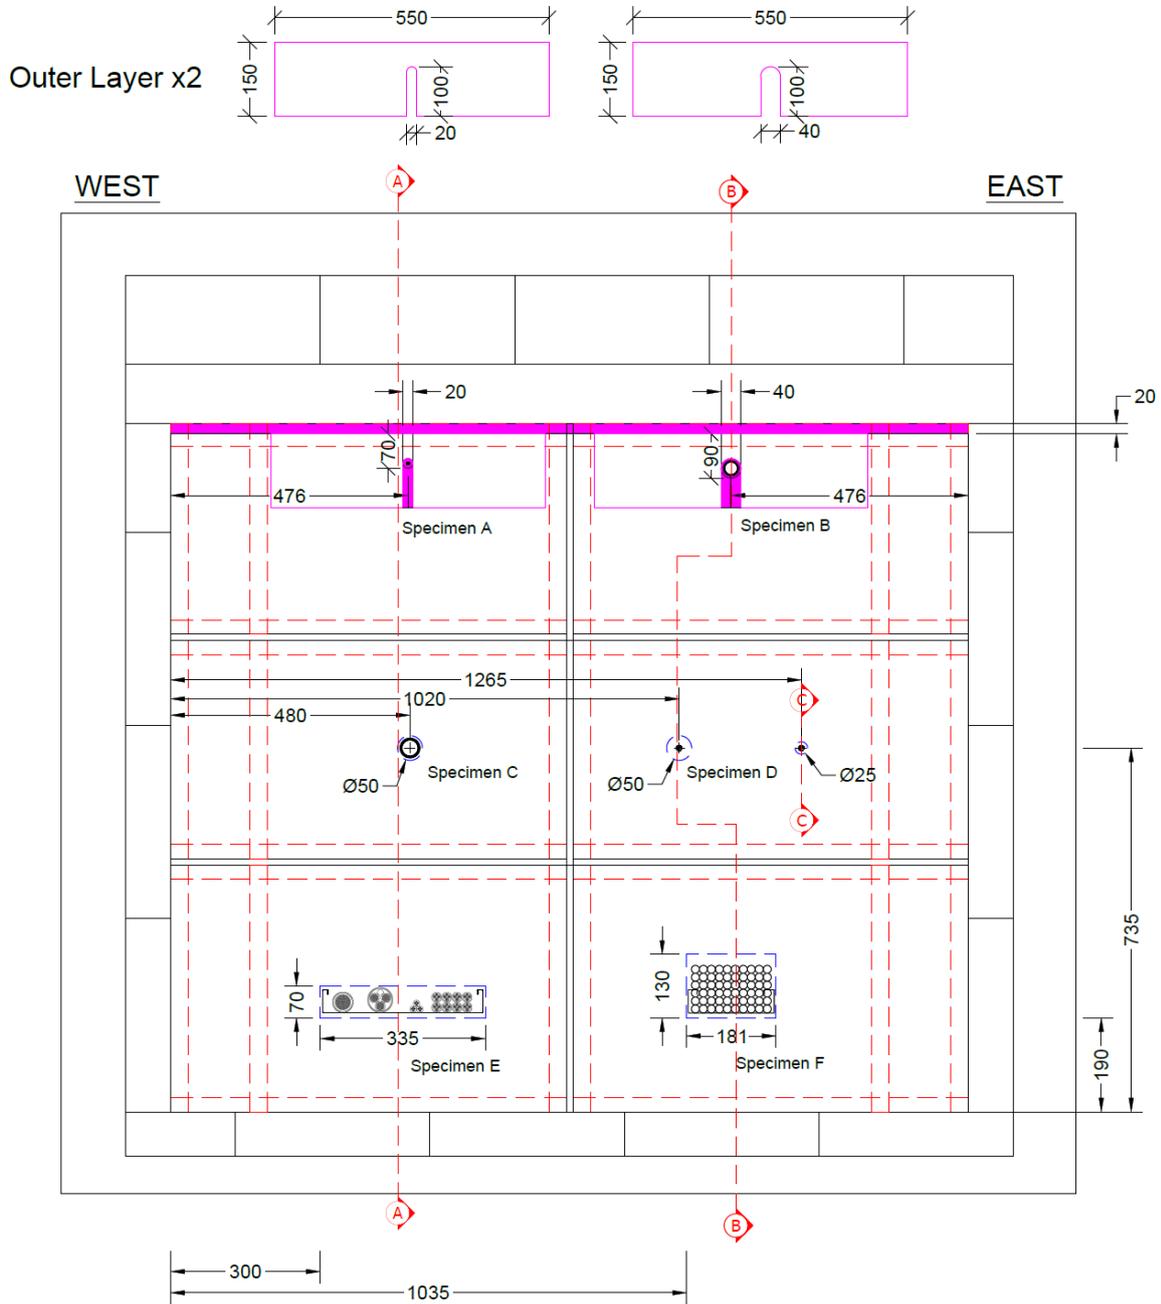
Figure 1 Elevation view of test specimen (unexposed side)

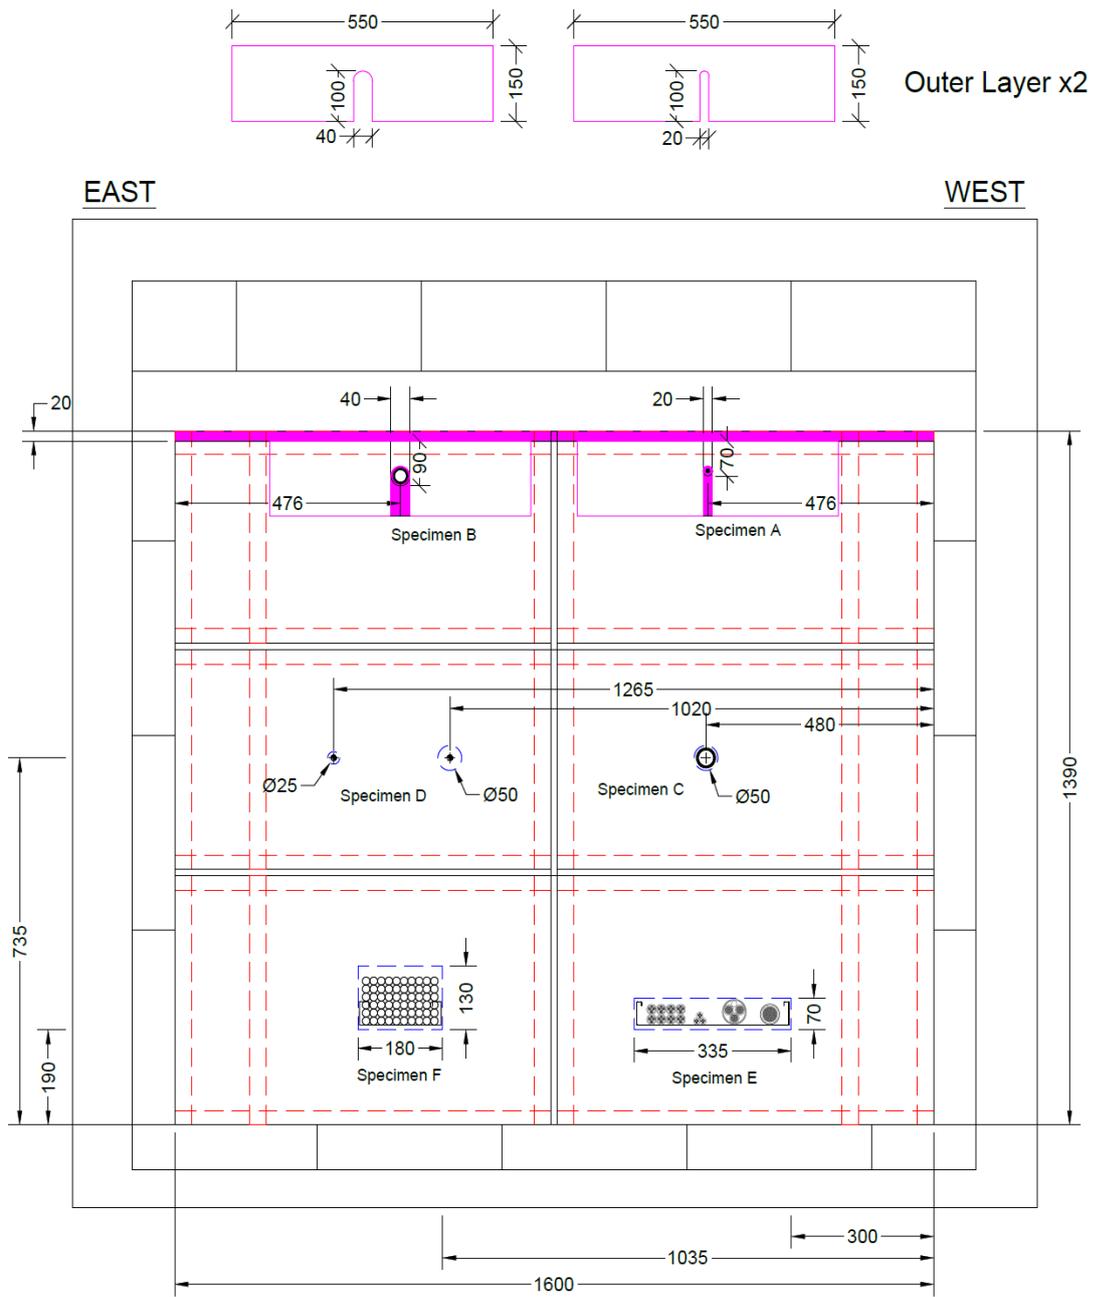
Figure 2 Elevation view of test specimen (exposed side)

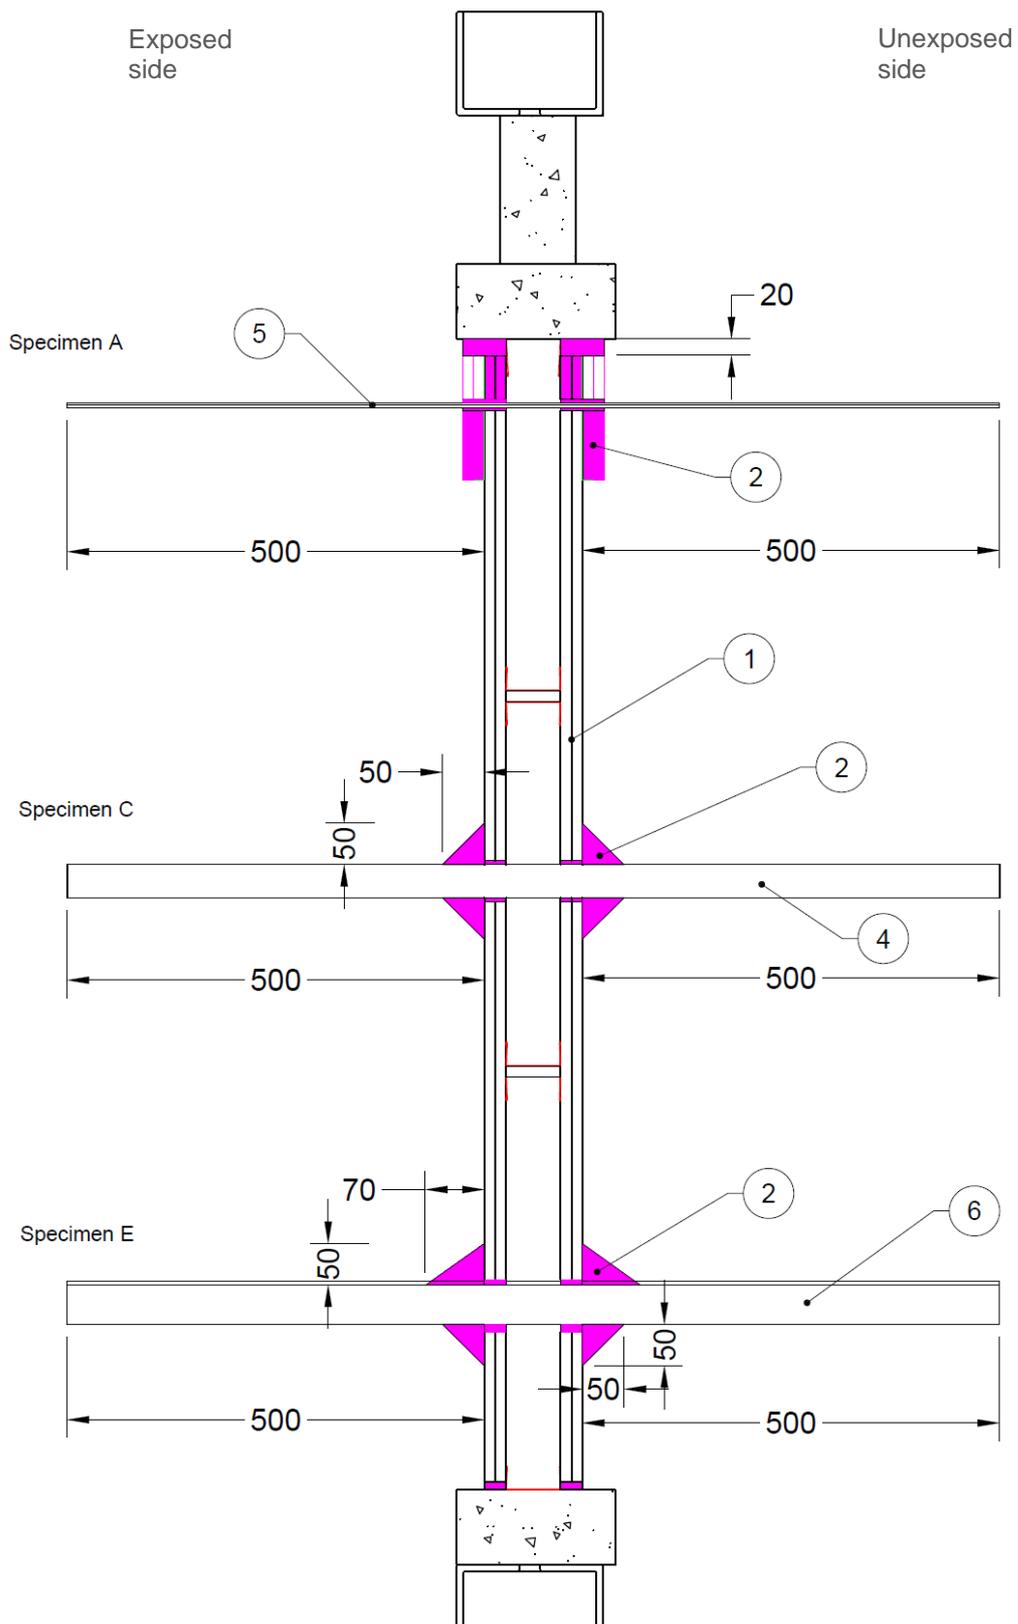
Figure 3 Cross section A-A

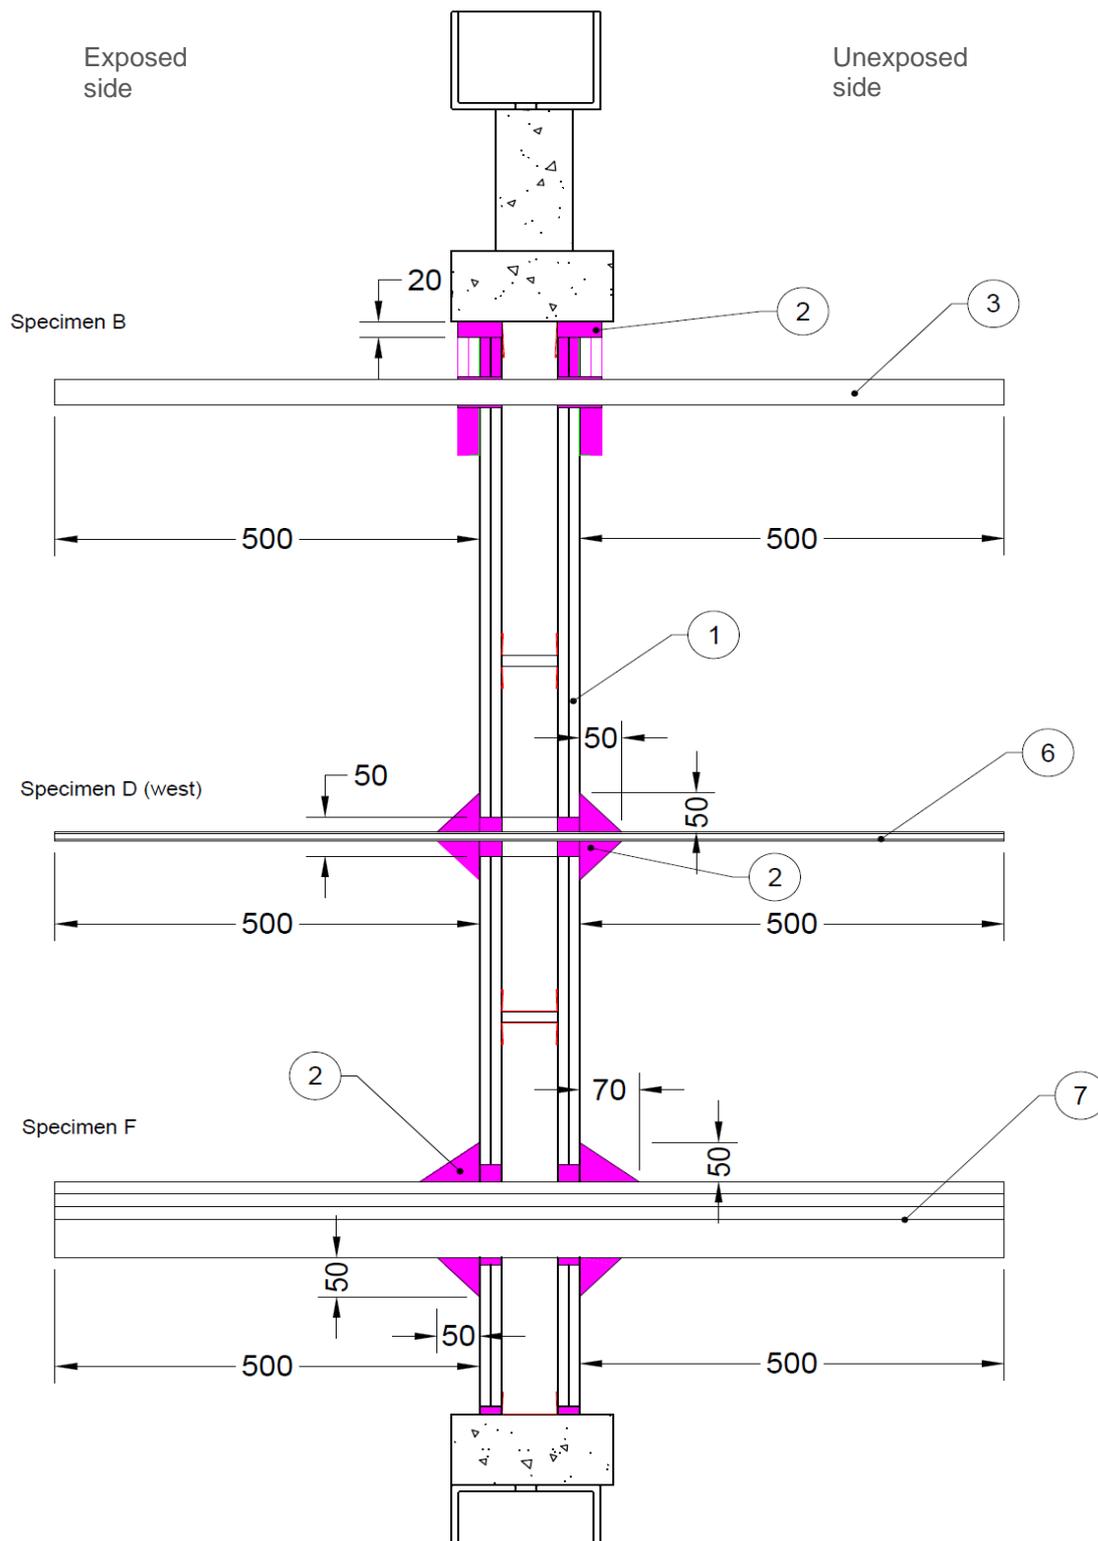
Figure 4 Cross section B-B

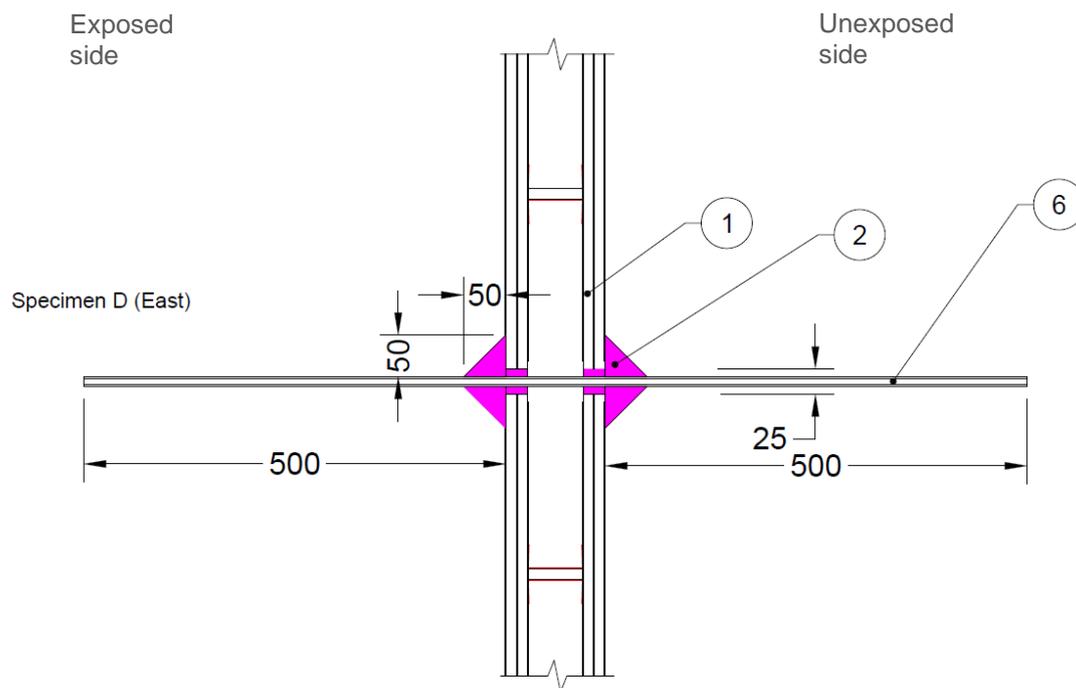
Figure 5 Cross section C-C

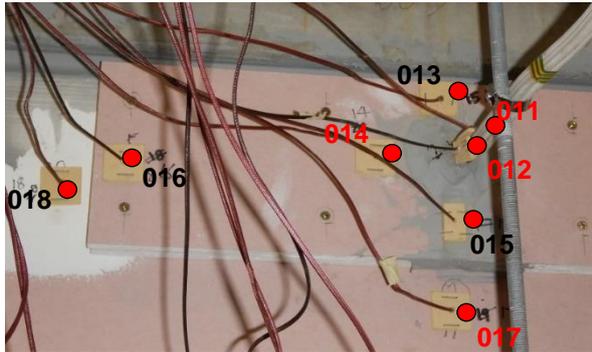
Figure 6 Penetration system A

Penetration system	T/C #	Description
A	011	On the top of the bundle of TPS cables, 25mm away from the sealant
	012	On the side of the bundle of TPS cables, 25mm away from the sealant
	013	On the extra protection plasterboard, 25mm away from the sealant
	014	On the extra protection plasterboard, 25mm away from the sealant
	015	On the sealant in the extra protection plasterboard channel, 25mm away from the sealant fillet cone
	016	On the extra protection plasterboard, 25mm away from the wall system below the extra protection plasterboard channel.
	017	On the wall system, 25mm away from the extra protection plasterboard
	018	On the wall system, 25mm away from the extra protection plasterboard
B	021	On the top of the 25mm galvanised steel pipe, 25mm away from the sealant
	022	On the side of the 25mm galvanised steel pipe, 25mm away from the sealant
	023	On the top of the sealant cone, 25mm away from the pipe.

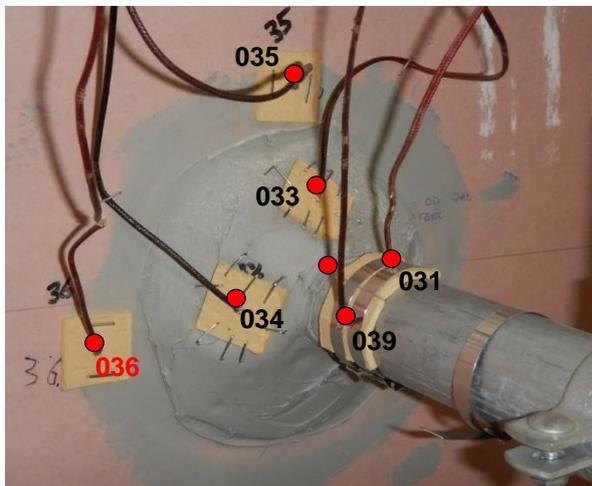
Figure 8 Penetration system C

024	On the side of the sealant cone, 25mm away from the pipe.
	025	On the extra protection plasterboard, 25mm away from the sealant
	026	On the extra protection plasterboard, 25mm away from the sealant
	027	On the sealant in the extra protection plasterboard channel, 25mm away from the sealant fillet cone
	028	On the extra protection plasterboard, 25mm away from the wall system below the extra protection plasterboard channel.
	029	On the wall system, 25mm away from the extra protection plasterboard
	030	On the wall system, 25mm away from the extra protection plasterboard
C	031	On the top of 32mm galvanised steel pipe, 25mm away from the sealant
	032	On the side of 32mm galvanised steel pipe, 25mm away from the sealant
	033	On the top of the sealant cone, 25mm away from the galvanised steel pipe
	034	On the side of the sealant cone, 25mm away from the galvanised steel pipe
	035	On the wall system, 25mm away from the top of the sealant cone

036	On the wall system, 25mm away from the side of the sealant cone
D (west)	041	On the top of the bundle of TPS cables, 25mm away from the sealant
	042	On the side of the bundle of TPS cables, 25mm away from the sealant
	043	On the top of the sealant cone, 25mm away from the bundle of TPS cable
	044	On the side of the sealant cone, 25mm away from the bundle of TPS cable
	045	On the wall system, 25mm away from the top of the sealant cone
	046	On the wall system, 25mm away from the side of the sealant cone
D (East)	051	On the top of the bundle of TPS cables, 25mm away from the sealant
	052	On the side of the bundle of TPS cables, 25mm away from the sealant
	053	On the top of the sealant cone, 25mm away from the bundle of TPS cable
	054	On the side of the sealant cone, 25mm away from the bundle of TPS cable
	055	On the wall system, 25mm away from the top of the sealant cone
	056	On the wall system, 25mm away from the side of the sealant cone

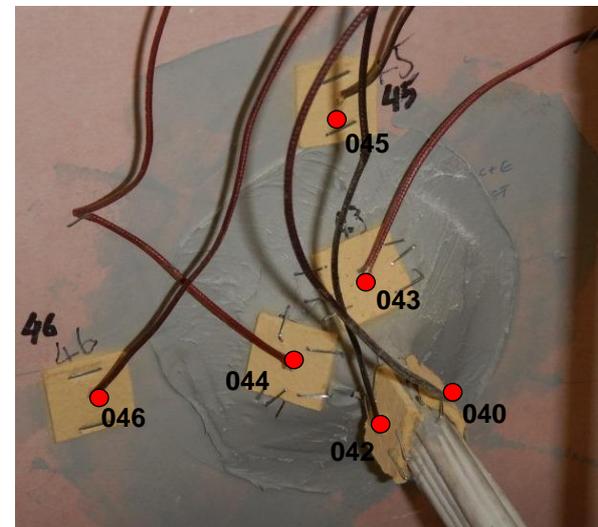
Figure 9 Penetration system D west

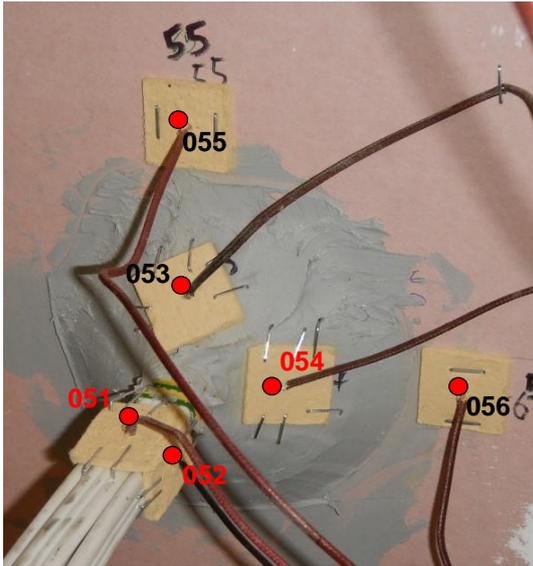
Figure 10 Penetration system D east

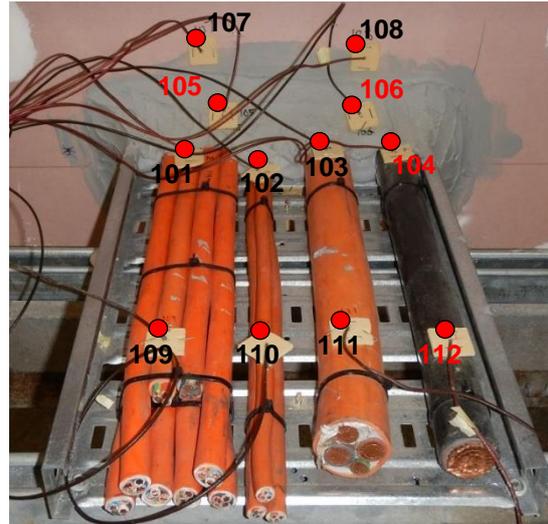
Figure 11 Penetration system D top

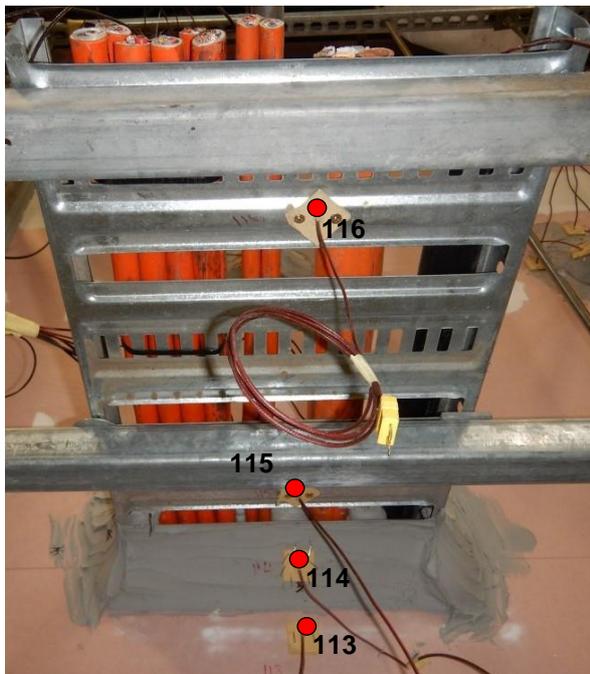
Figure 12 Penetration system E bottom

Penetration system	T/C #	Description
E	101	On the 16mm ² cables, 25mm away from the sealant cone
	102	On the 6mm ² cable, 25mm away from the sealant cone
	103	On the 185mm ² cable, 25mm away from the sealant cone
	104	On the 630mm ² cable, 25mm away from the sealant cone
	105	On the sealant cone, 25mm away from the 16mm ² cables
	106	On the sealant cone, 25mm away from the 630mm ² cable
	107	On the wall system, 25mm away from the top of sealant cone.
	108	On the wall system, 25mm away from the top of sealant cone.
	109	On the 16mm ² cable, 400mm away from the wall system
	110	On the 6mm ² cable, 400mm away from the sealant cone
	111	On the 185mm ² cable, 400mm away from the sealant cone
	112	On the 630mm ² cable, 400mm away from the sealant cone
	113	On the wall system, 25mm away from the bottom of sealant cone.
	114	On the sealant cone, 25mm away from the bottom of cable tray
	115	On the bottom of cable tray, 25mm away from the sealant

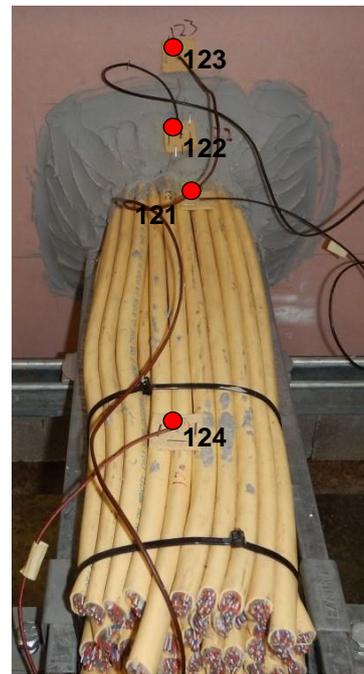
Figure 13 Penetration system F top

116	On the bottom of cable tray, 400mm away from the wall system
F	121	On the communication cables, 25mm away from the sealant cone
	122	On the sealant cone, 25mm away from the communication cables
	123	On the wall system, 25mm away from the top of sealant cone
	124	On the communication cables, 400mm away from the wall
	125	On the wall system, 25mm away from the bottom of sealant cone
	126	On the sealant cone, 25mm away from the bottom of communication cables.
	127	On the bottom of cable tray, 25mm away from the bottom of sealant cone
	128	On the bottom of cable tray, 400mm away from the wall system

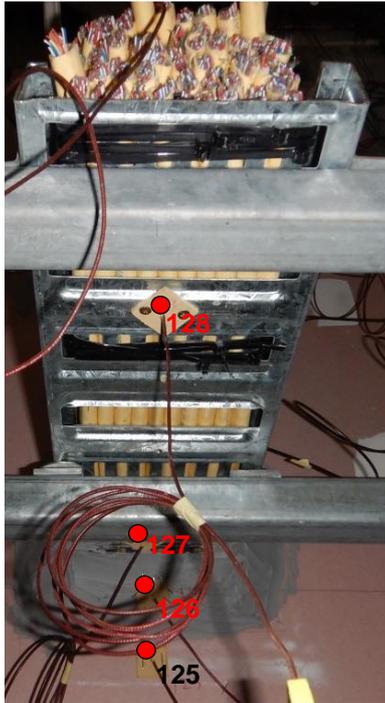
Figure 14 Penetration system F bottom

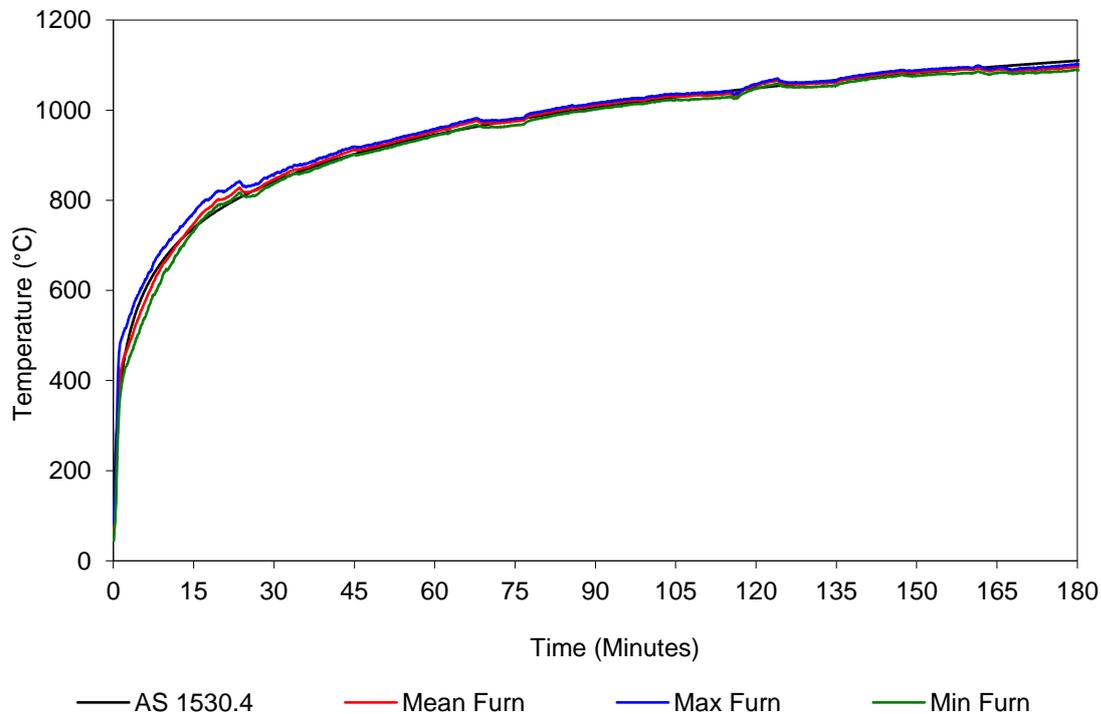
Figure 7: Furnace thermocouple temperature vs time

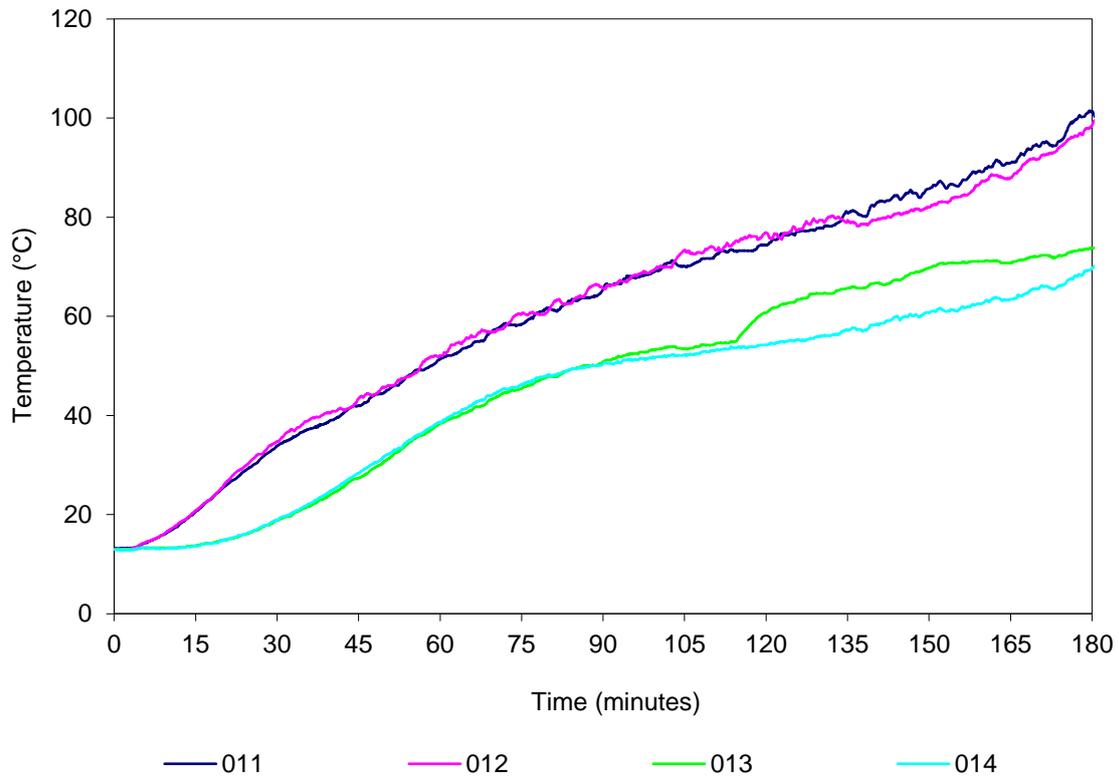
Figure 15 Penetration system A (around the bundle of cable) – temperature vs time

Penetration system	T/C #	Description ¹	Temp (°C) at t (minutes)					Limit ² (minutes)
			t=0	t=60	t=90	t=120	t=180	
A	011	On the service	13	52	65	75	101	-
	012	On the service	13	52	66	76	98	-
	013	On the extra protection plasterboard	13	39	51	61	74	-
	014	On the extra protection plasterboard	13	39	50	54	69	-
	015	On the sealant	13	44	61	69	80	-
	016	On the extra protection plasterboard	13	37	47	50	62	-
	017	On the separating element	13	65	72	76	104	-
	018	On the separating element	13	63	71	75	103	-
B	021	On the service	13	74	92	109	143	-
	022	On the service	13	74	93	109	144	--
	023	On the sealant cone	13	90	97	105	125	-
	024	On the sealant cone	13	91	106	122	167	-
	025	On the extra protection plasterboard	13	43	55	66	80	-
	026	On the extra protection plasterboard	13	45	56	60	76	-
	027	On the sealant	13	55	69	74	89	-
	028	On the extra protection plasterboard	13	36	46	50	64	-
	029	On the separating element	13	70	74	79	119	-

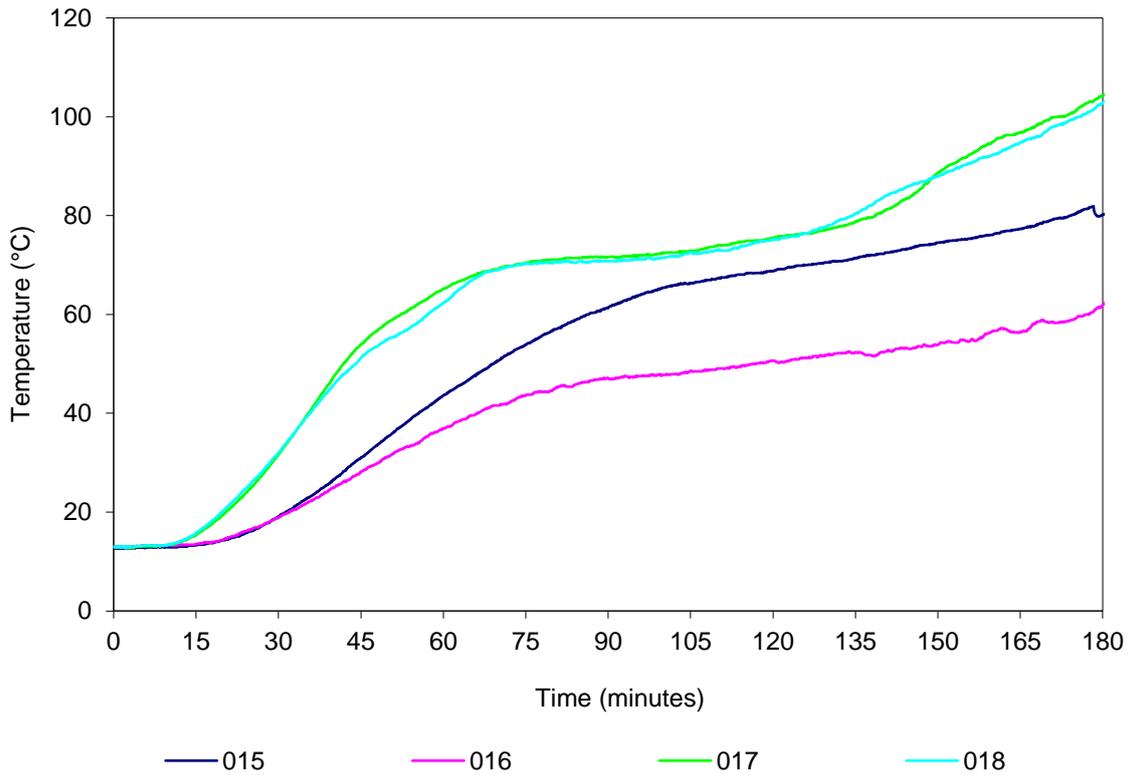
Figure 16 Penetration system A (on the extra protection board and wall system) – temperature vs time

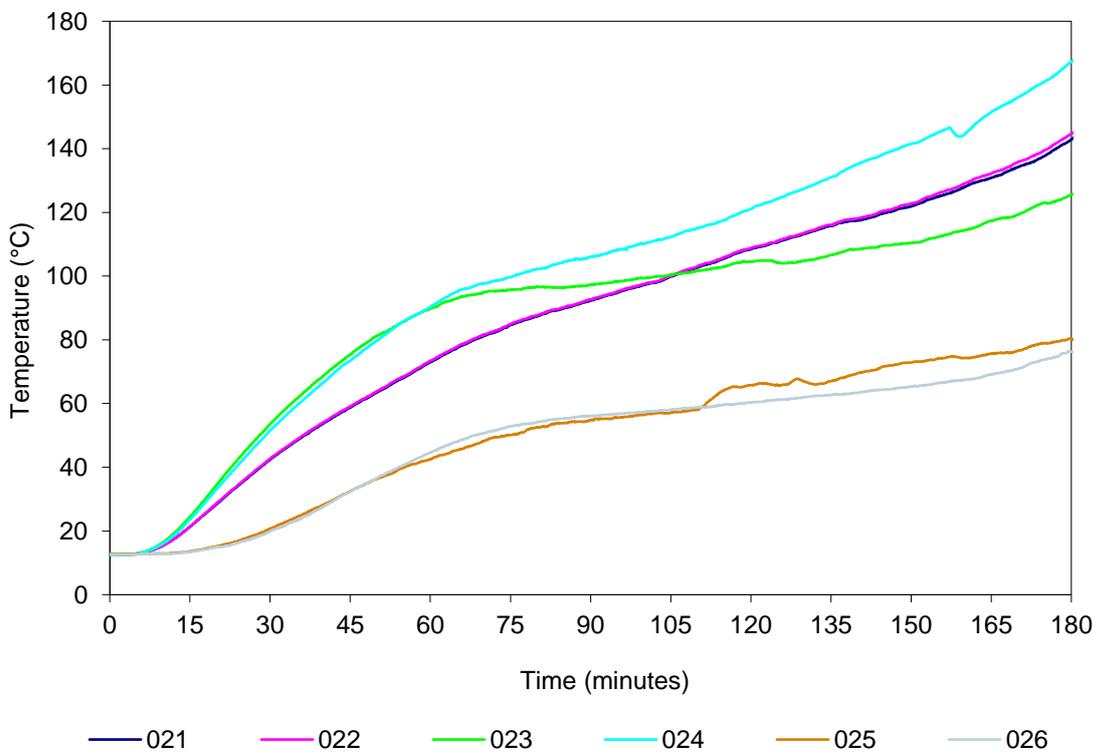
Figure 17 Penetration system B (near the galvanised steel pipe) – temperature vs time

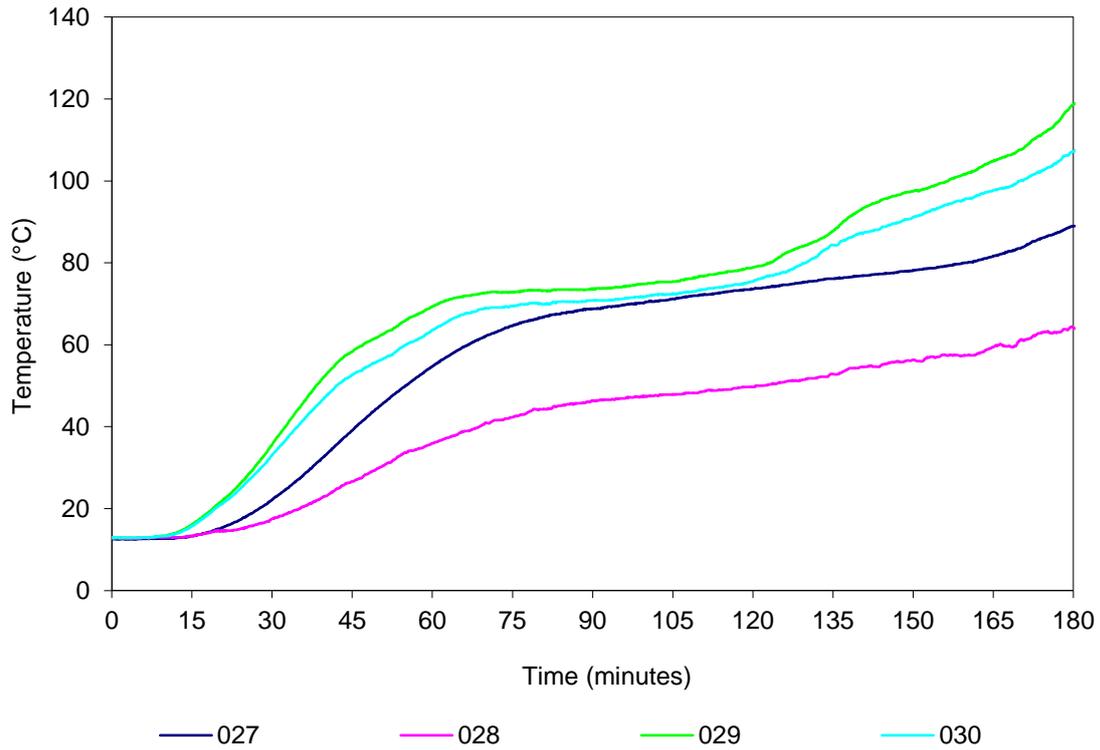
Figure 18 Penetration system B (on the extra protection board and wall system) – temperature vs time

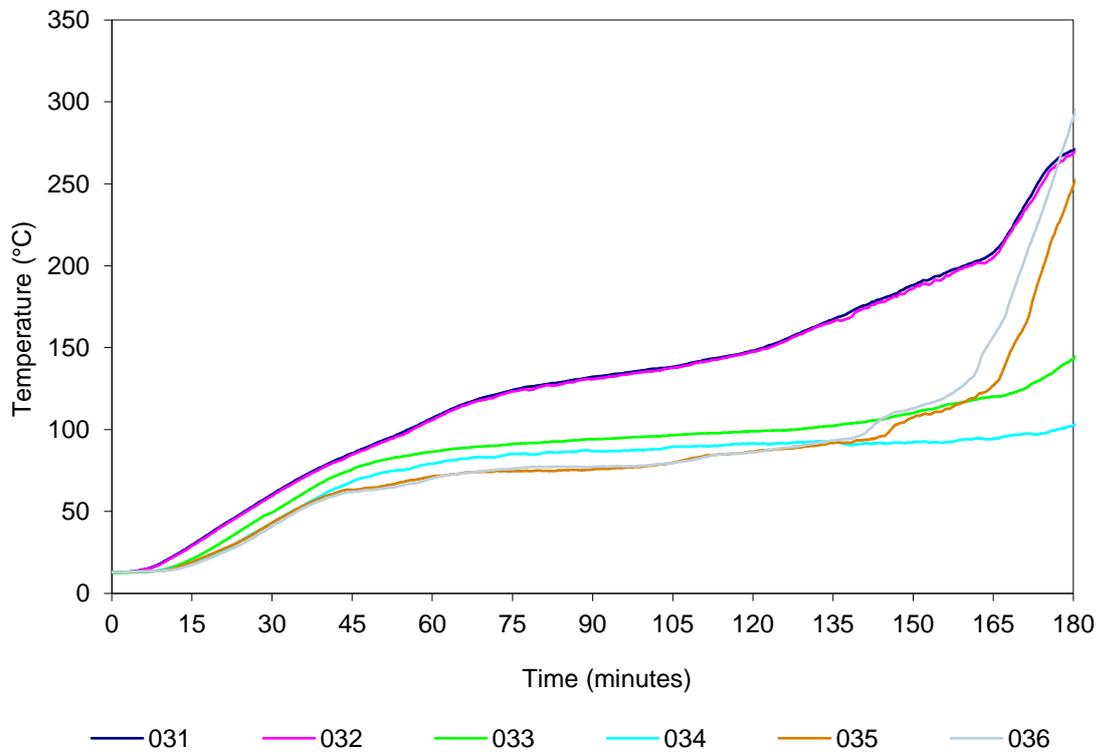
Figure 19 Penetration system C – temperature vs time

Time		Observation
Min	Sec	
120	00	The specimen had continued to maintain integrity and insulation in accordance with AS 1530.4-2014
153	50	TC 031 on the metal pipe, 25mm away from sealant recorded a temperature of 193°C. Failure of insulation in accordance with AS 1530.4-2014 clause 2.13.3(b), where the maximum temperature of Thermocouple TC 031 exceeded the initial temperature by more than 180°C.
180	00	The specimen had continued to maintain integrity in accordance with AS 1530.4-2014.
180	00	Test stopped at the request of the sponsor.
Penetration system D		
00	00	Fire resistance test commenced, and the ambient temperature was approximately 13°C.
30	00	The specimen had continued to maintain integrity and insulation in accordance with AS 1530.4-2014.
60	00	The specimen had continued to maintain integrity and insulation in accordance with AS 1530.4-2014.
72	30	The sealant cone had expanded
90	00	The specimen had continued to maintain integrity and insulation in accordance with AS 1530.4-2014.

030	On the separating element	13	64	71	76	107	-
C	031	On the service	13	108	132	148	270	153
	032	On the service	13	107	131	148	268	155
	033	On the sealant cone	13	87	94	99	143	-
	034	On the sealant cone	13	79	87	92	102	-
	035	On the separating element	13	72	76	87	247	173
	036	On the separating element	13	71	77	86	288	169
D (west)	041	On the service	13	117	150	169	325	137
	042	On the service	13	121	156	174	282	156
	043	On the sealant cone	13	79	85	90	104	-
	044	On the sealant cone	13	76	84	88	102	-
	045	On the separating element	13	74	75	85	280	171
	046	On the separating element	13	73	76	85	323	168
D (east)	051	On the service	13	121	156	188	348	125
	052	On the service	13	101	125	151	266	164
	053	On the sealant cone	13	81	88	93	122	-
	054	On the sealant cone	12	73	83	86	101	-

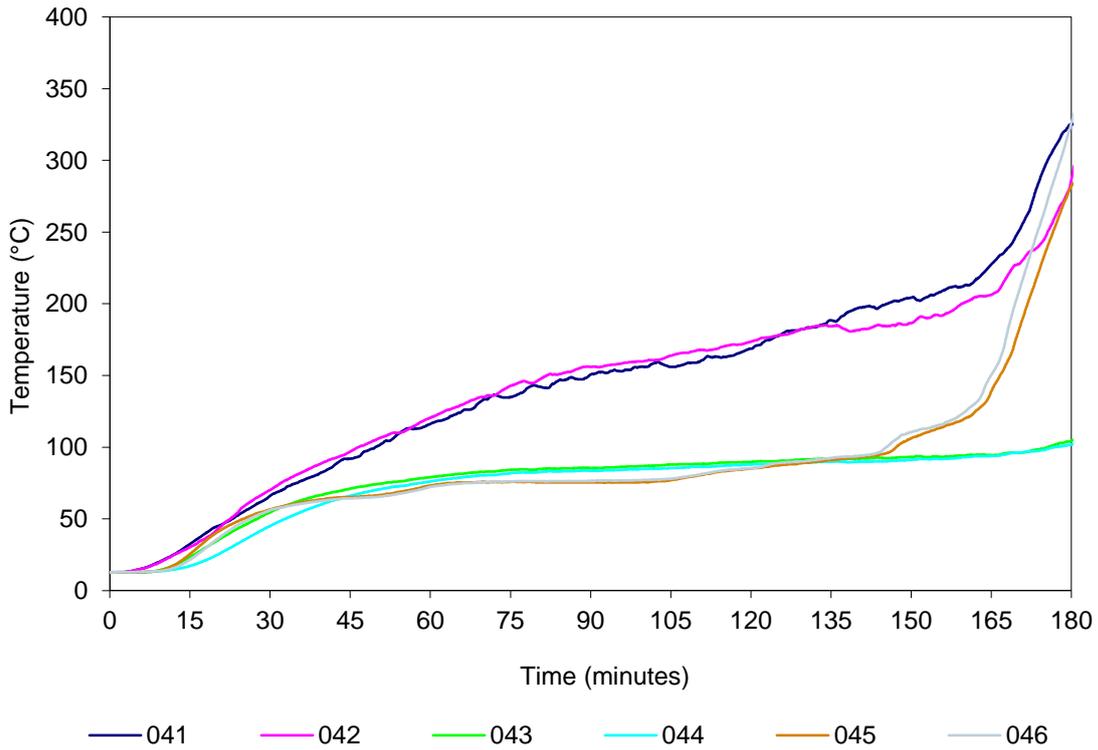
Figure 20 Penetration system D (on the west penetration) – temperature vs time

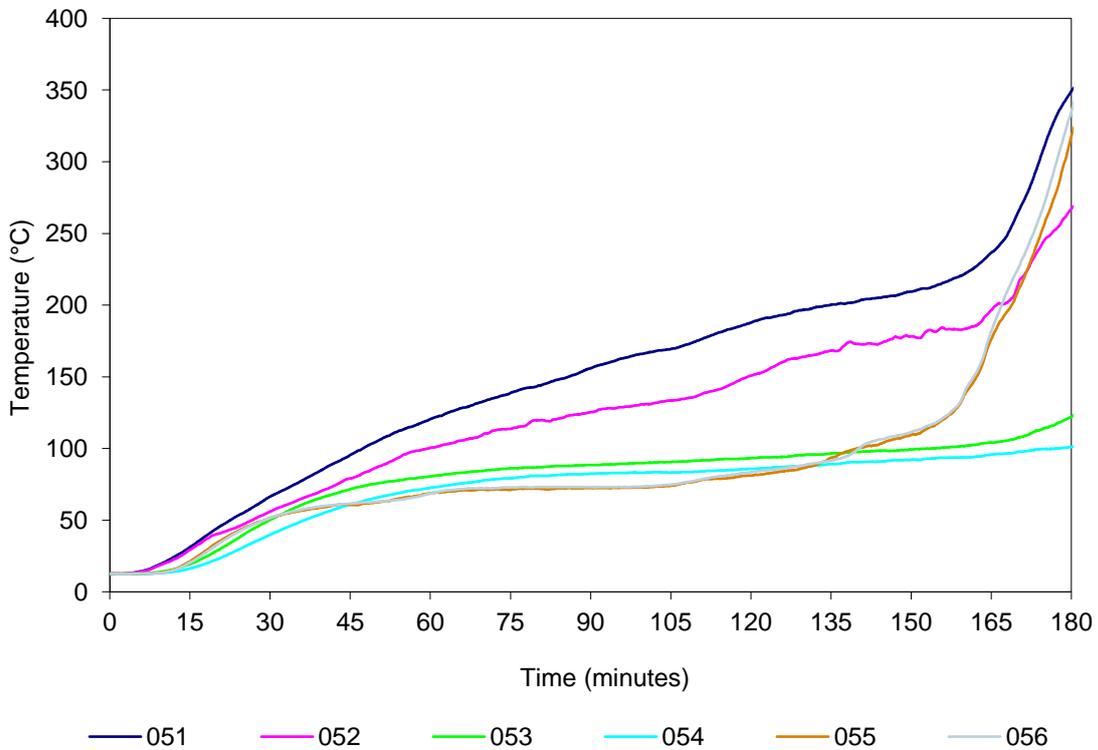
Figure 21 Penetration system D (on the east penetration) – temperature vs time

120	00	The specimen had continued to maintain integrity and insulation in accordance with AS 1530.4-2014.
125	15	TC 051 on the bundle of TPS cable on the east side hole, 25mm away from sealant recorded a temperature of 193°C. Failure of insulation in accordance with AS 1530.4-2014 clause 2.13.3(b), where the maximum temperature of Thermocouple TC 051 exceeded the initial temperature by more than 180°C.
137	40	TC 041 on the bundle of TPS cable on the west side hole, 25mm away from sealant recorded a temperature of 193°C. Failure of insulation in accordance with AS 1530.4-2014 clause 2.13.3(b), where the maximum temperature of Thermocouple TC 041 exceeded the initial temperature by more than 180°C.
180	00	The specimen had continued to maintain integrity in accordance with AS 1530.4-2014.
180	00	Test stopped at the request of the sponsor.
Penetration system E		
00	00	Fire resistance test commenced, and the ambient temperature was approximately 13°C.

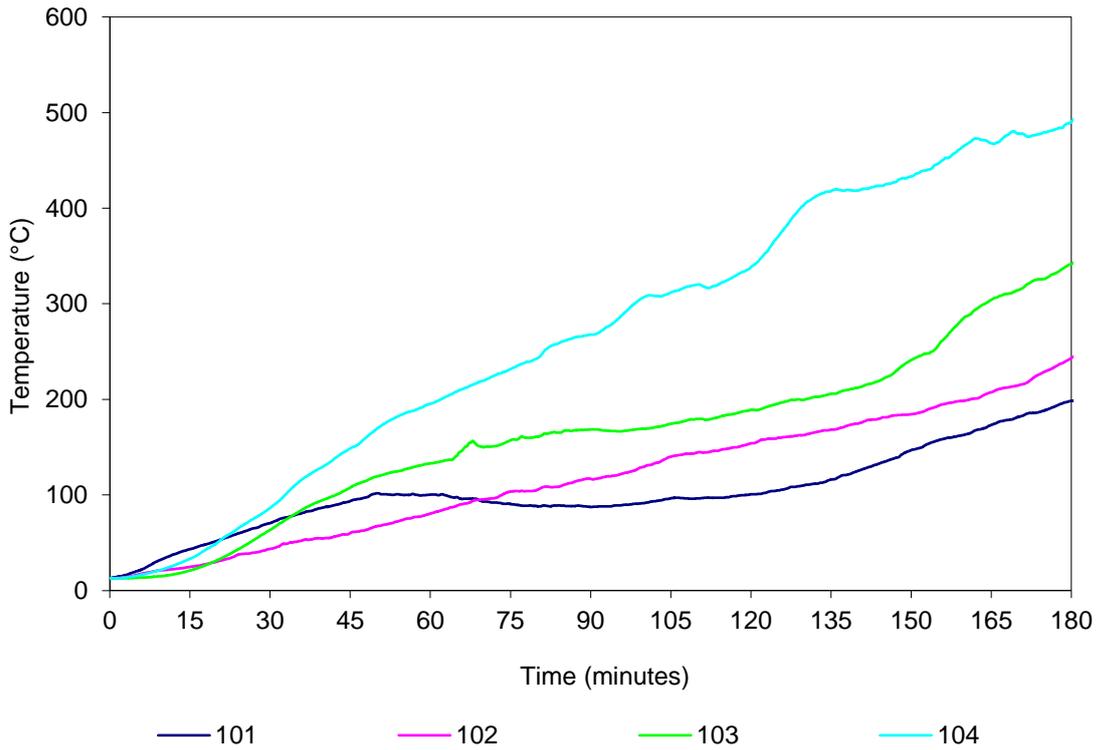
Figure 22 Penetration system E (on the cables, 25 mm away from sealant) – temperature vs time

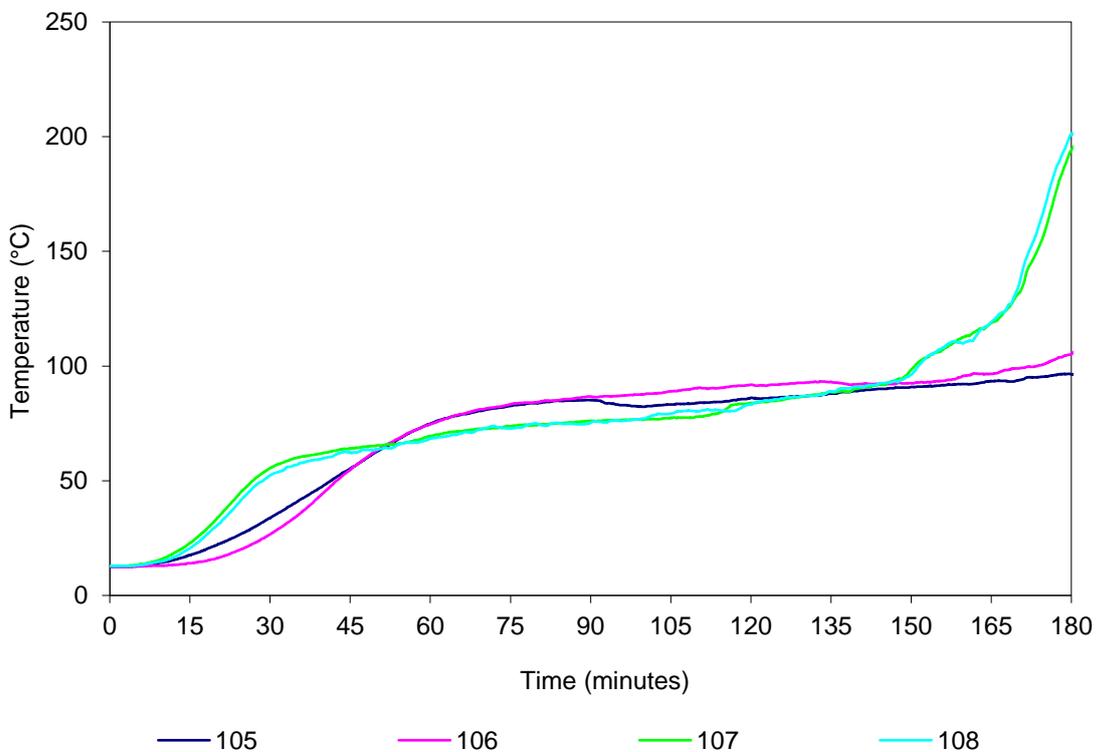
Figure 23 Penetration system E (on the sealant and 25 mm away from sealant) – temperature vs time

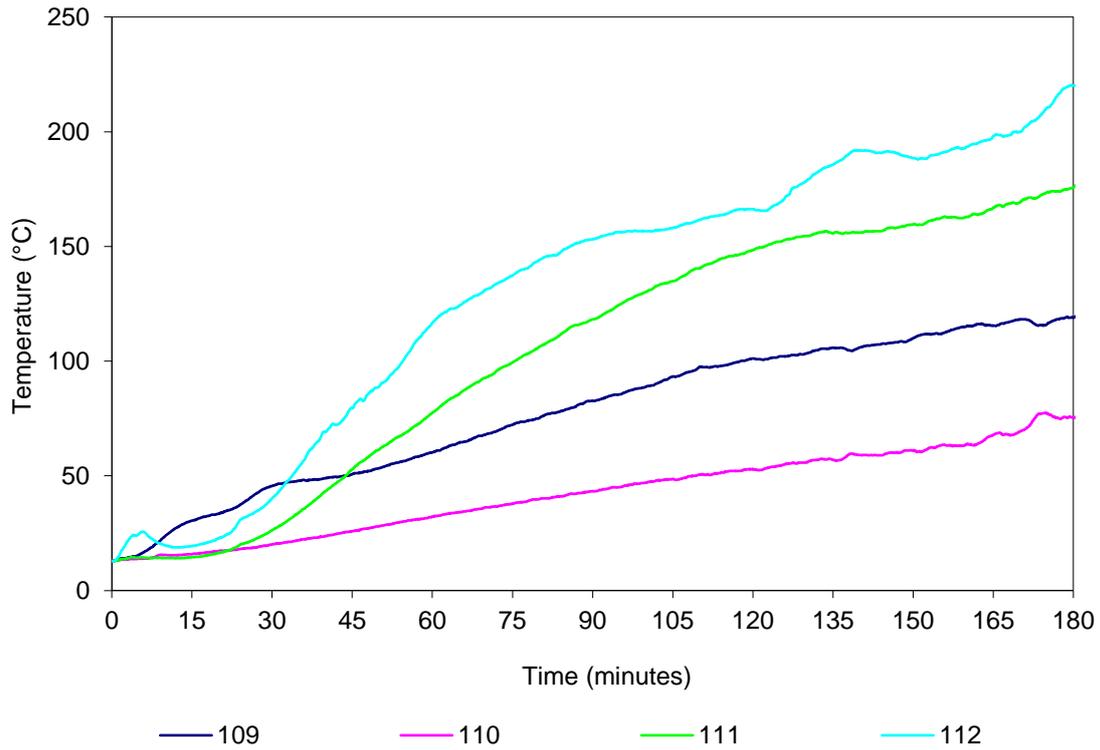
Figure 24 Penetration system E (on the cables, 400 mm away from wall system)– temperature vs time

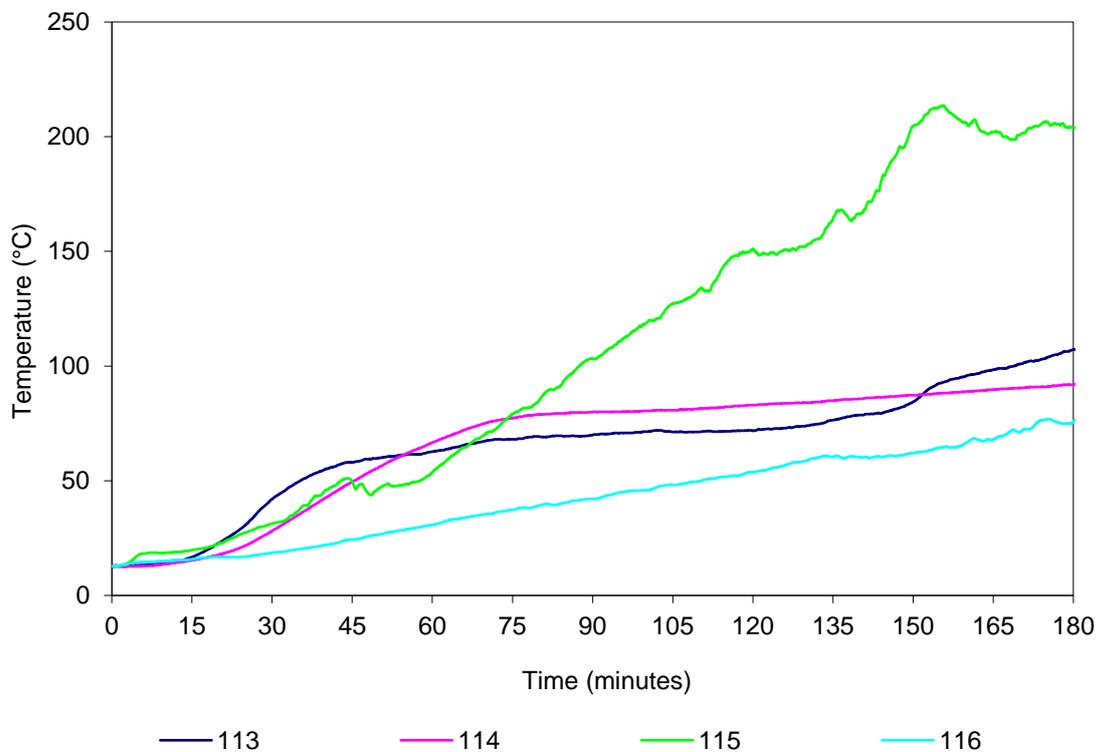
Figure 25 Penetration system E (TC on the bottom side of the specimen) – temperature vs time

Penetration system	T/C #	Description ¹	Temp (°C) at t (minutes)					Limit ² (minutes)
			t=0	t=60	t=90	t=120	t=180	
	055	On the separating element	13	69	73	81	314	167
	056	On the separating element	13	69	73	84	332	166
E	101	On the 16 mm ² cable	13	100	88	101	198	177
	102	On the 6 mm ² cable	13	81	117	154	242	155
	103	On the 185 mm ² cable	13	133	168	189	341	123
	104	On the 630 mm ² cable	13	196	268	340	489	58
	105	On the sealant cone	13	75	85	86	97	-
	106	On the sealant cone	13	75	87	92	105	-
	107	On the separating element	13	70	76	84	193	179
	108	On the separating element	13	69	75	84	200	178
	109	On the 16 mm ² cable	13	60	83	101	119	-
	110	On the 6 mm ² cable	13	32	43	53	76	-
	111	On the 185 mm ² cable	13	78	118	149	176	-
	112	On the 630 mm ² cable	13	118	153	166	220	157
	113	On the separating element	13	63	70	72	107	-
	114	On the sealant cone	13	67	80	83	92	-
	115	On the bottom of cable tray	13	55	103	150	204	146
