Fire resistance test report

Test standard: Sections 2 and 10 of AS 1530.4:2014

Test sponsor: H B Fuller Aus Co P/L; USG Boral

Job number: 48763900

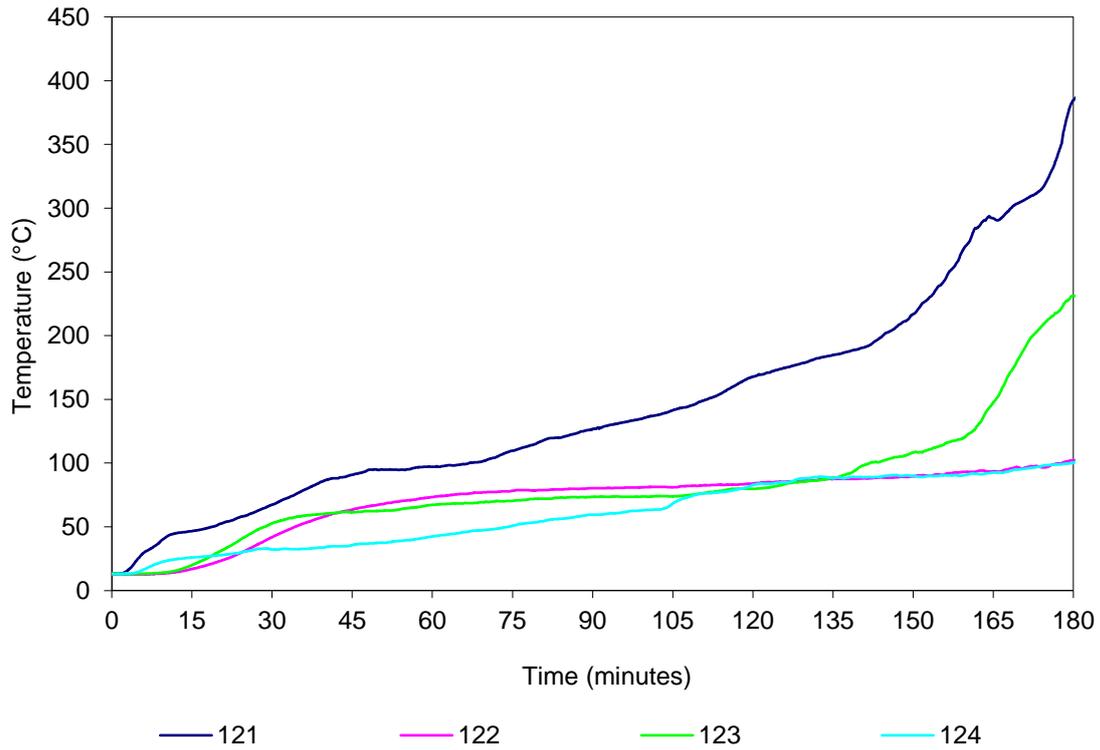
Figure 26 Penetration system F (on the top side) – temperature vs time

116	On the bottom of cable tray	13	31	42	54	75	-
F	121	On the communication cable	13	97	127	168	383	142
	122	On the sealant cone	13	74	80	84	102	-
	123	On the separating element	13	67	74	80	231	171
	124	On the communication cable	13	43	60	83	100	-
	125	On the separating element	13	64	70	73	113	-
	126	On the sealant cone	13	57	71	76	87	-
	127	On the bottom of cable tray	13	82	135	189	299	122
	128	On the bottom of cable tray	13	38	47	64	98	-

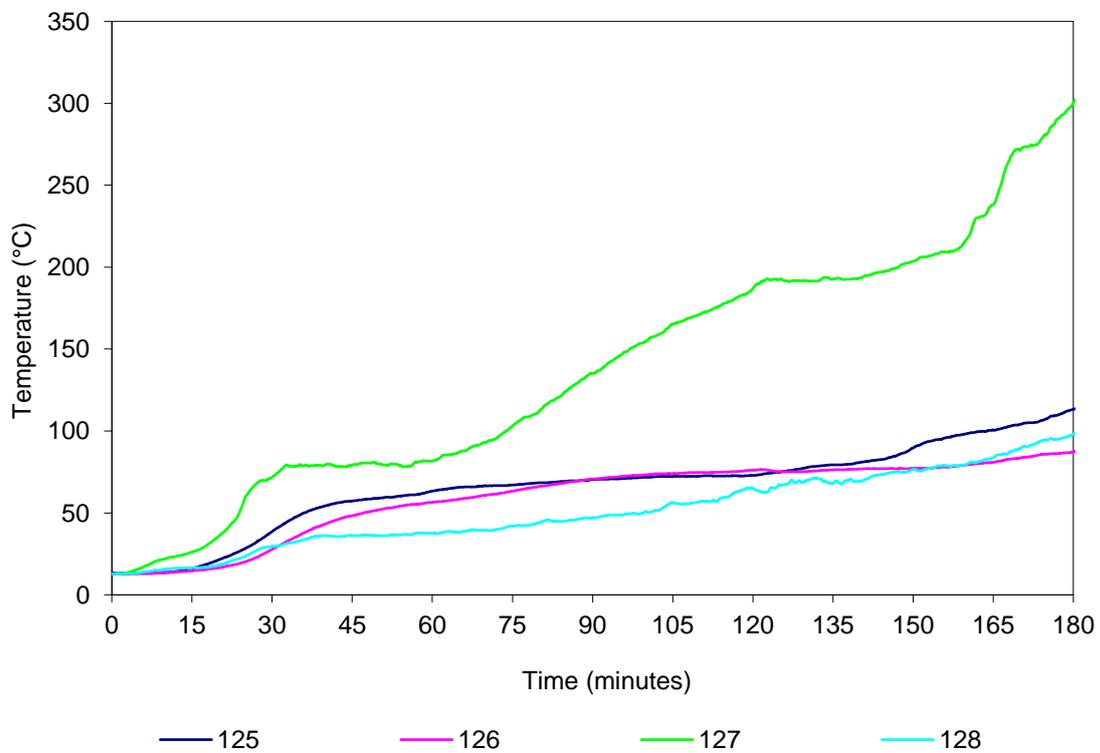
Figure 27 Penetration system F (on the bottom side) – temperature vs time

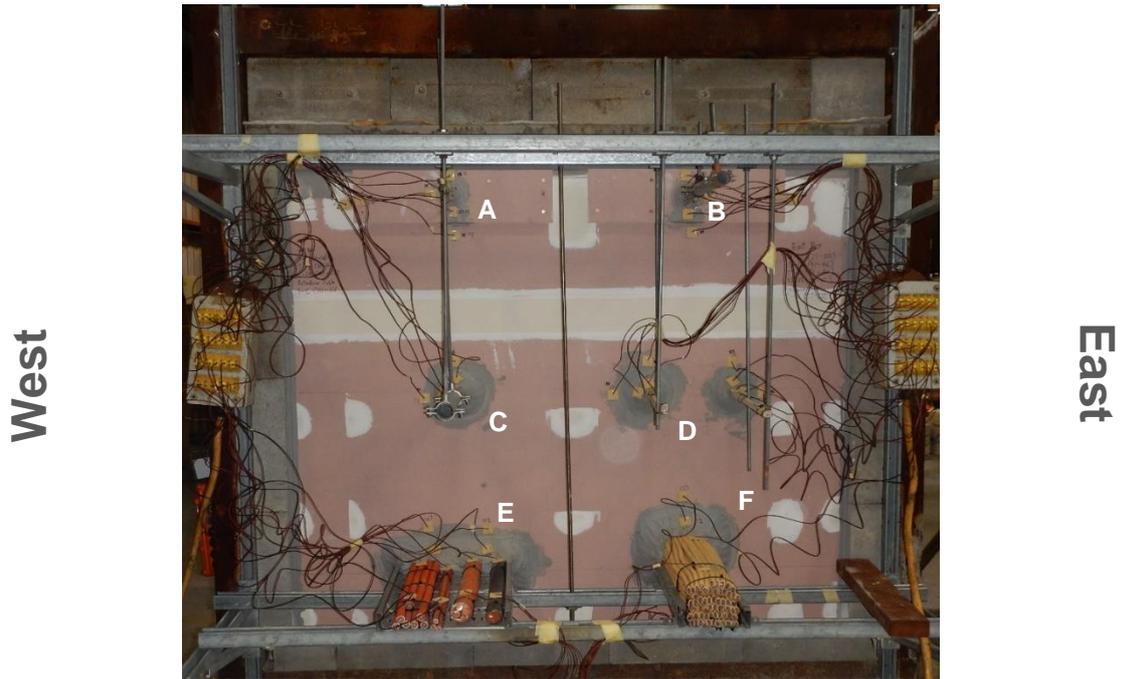
Figure 28 Unexposed face of the specimen before the start of the test

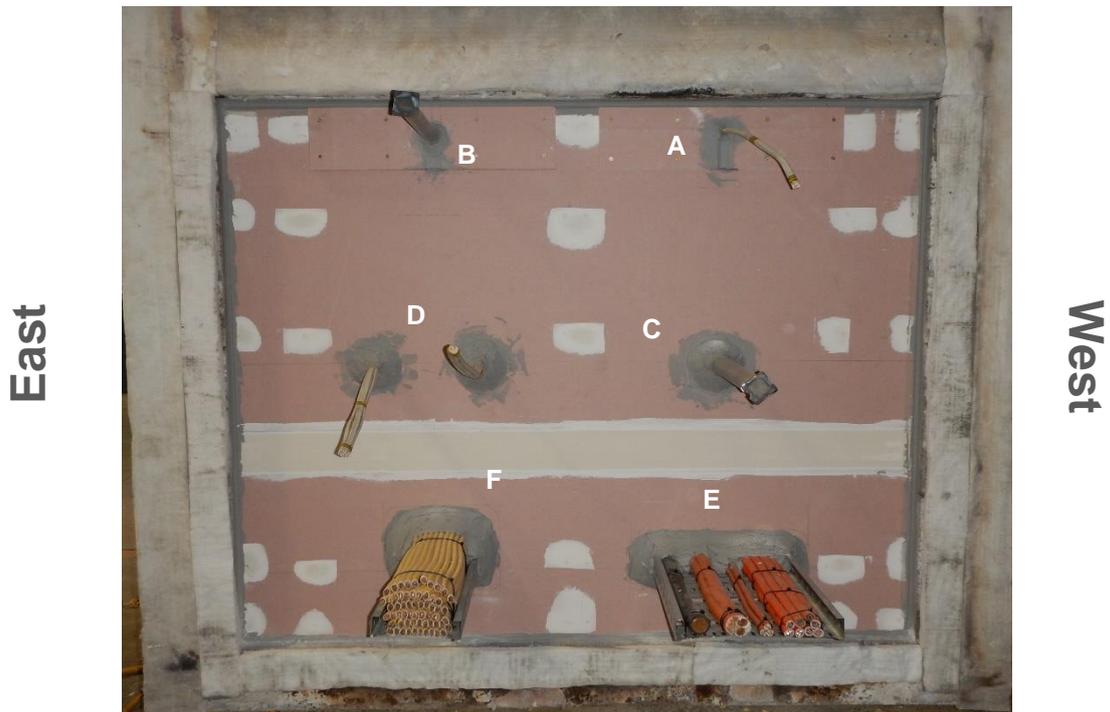
Figure 29 Exposed face of the specimen before the start of the test

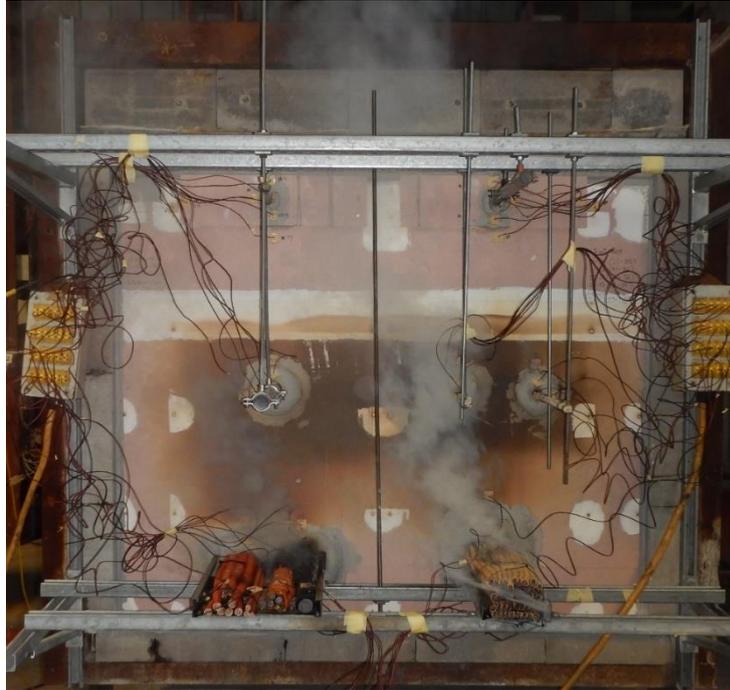
Figure 30 Unexposed face of the specimen at the end of the test

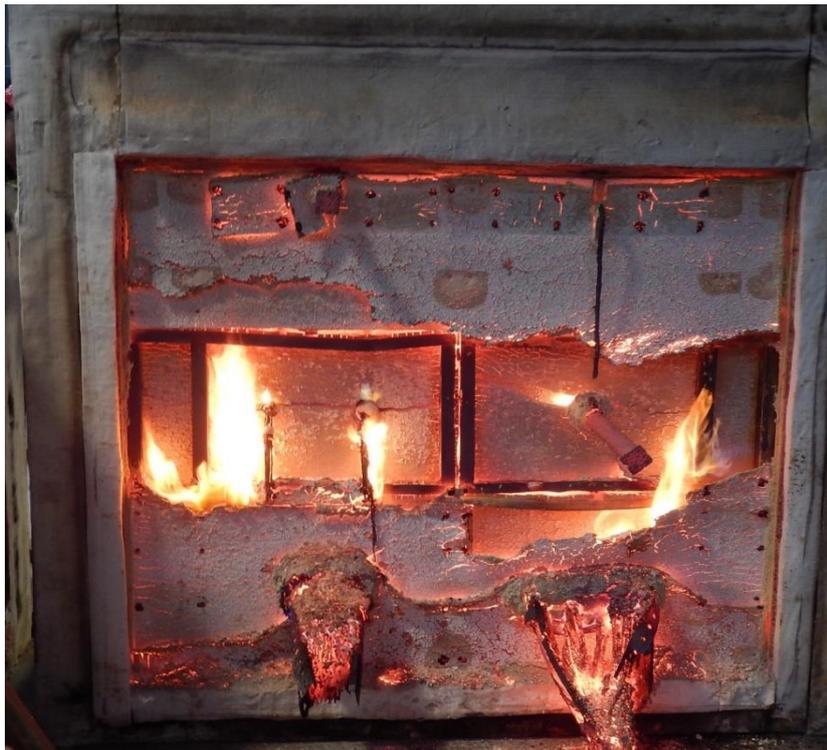
Figure 31 Exposed face of the specimen at the end of the test
