# FIRE TEST REPORT

## FP20542-02-1

**THE FIRE RESISTANCE IN ACCORDANCE WITH AS 1530.4:2014 OF A CONTROL JOINT AND THREE PERIMETER EDGE SEALS INSTALLED IN A 75 MM THICK HEBEL POWERPANEL SINGLE MESH WALL**

**FP20542-02-1**

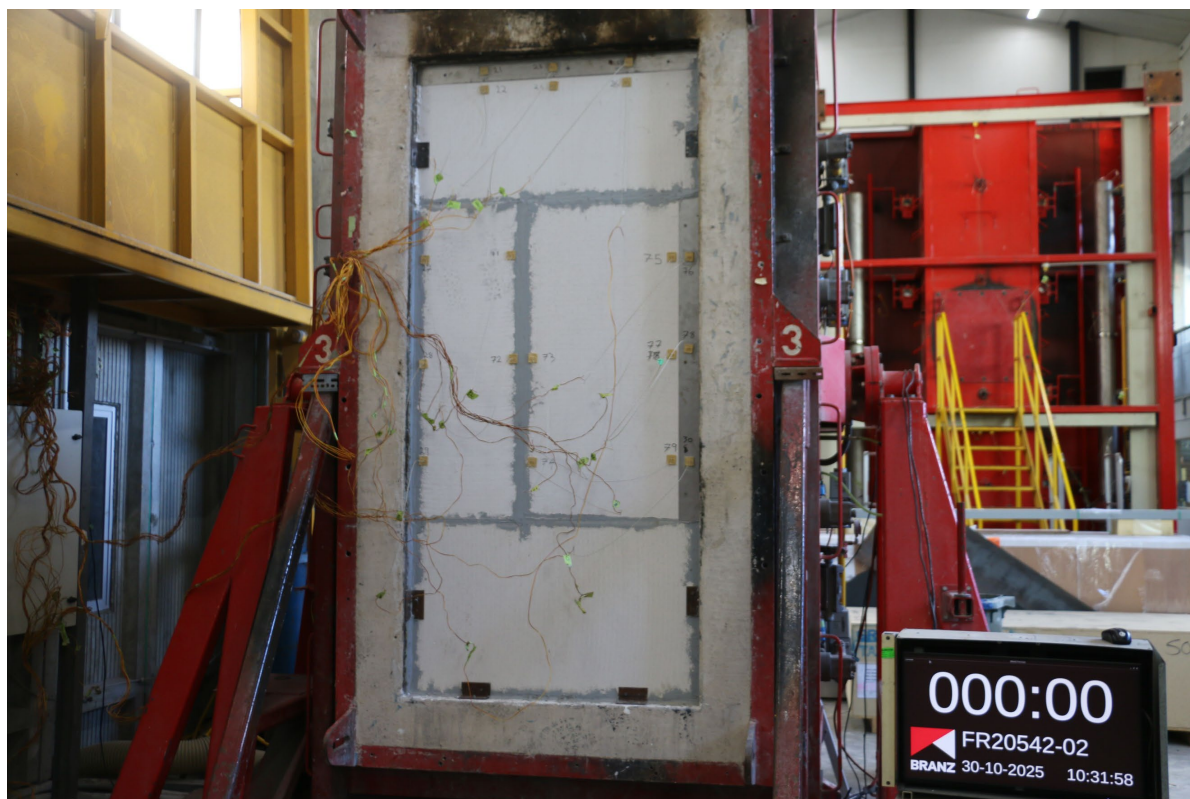
Photo 1: The Unexposed Face of the Assembly Prior to Testing

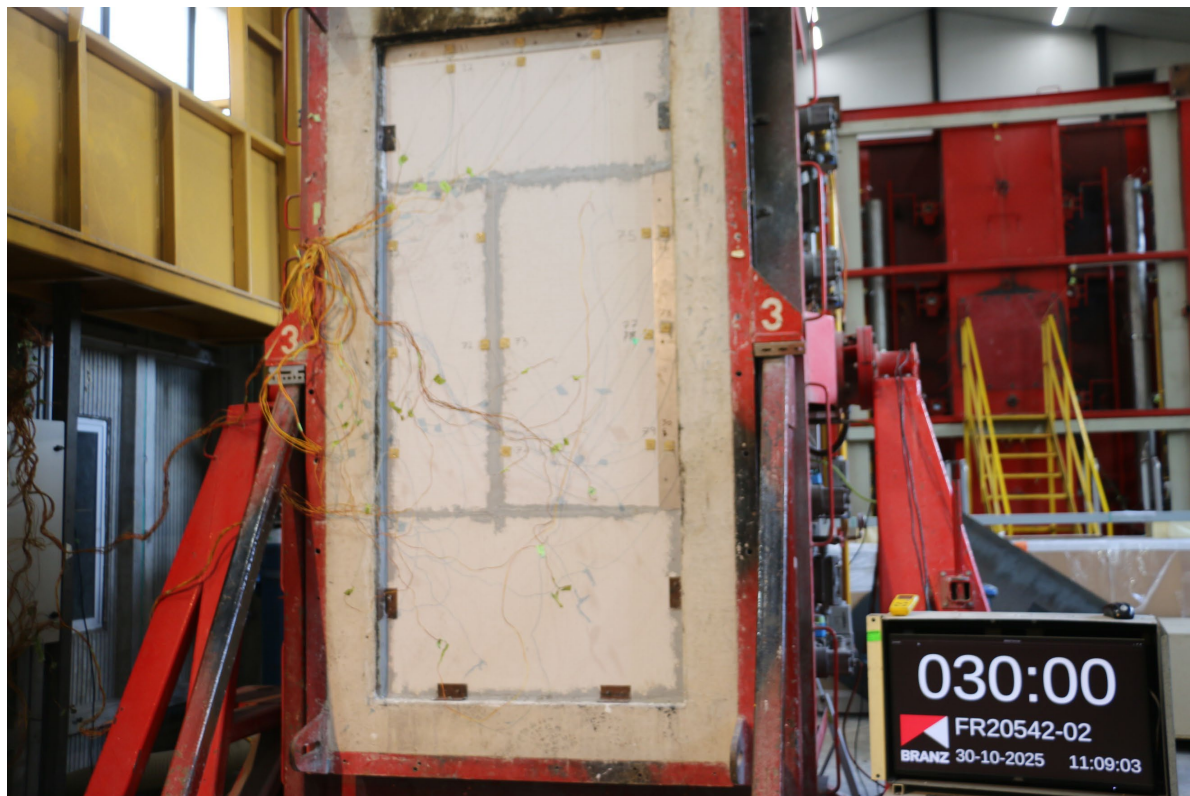
Photo 2: The Unexposed Face of the Test Assembly After a Duration of 30 Minutes

| Time (Min:Sec) | Test Face | Observations |
|---|---|---|
| 30:00 | U | The sealant on Specimen B has started to swell/expand. |

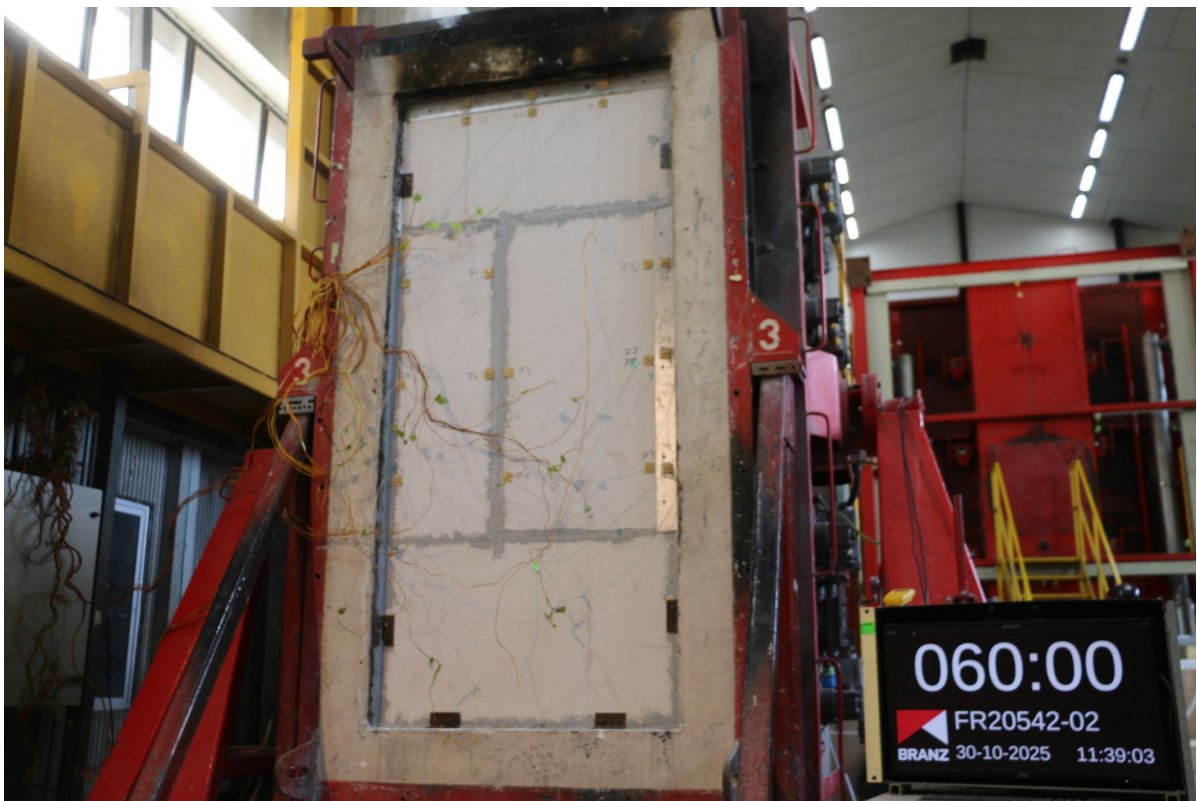
Photo 3: The Unexposed Face of the Test Assembly After a Duration of 60 Minutes

| Time (Min:Sec) | Test Face | Observations |
|---|---|---|
| 55:00 | U | Cracks are forming in the Hebel panels, one crack is located in the lower panel with another crack in the right-hand vertical panel, 75 mm below TC75 and running across to Specimen C. |
| 58:00 | U | The sealant on Specimen C has started to swell/expand. |
| 60:00 | | The specimens continue to maintain Integrity. |

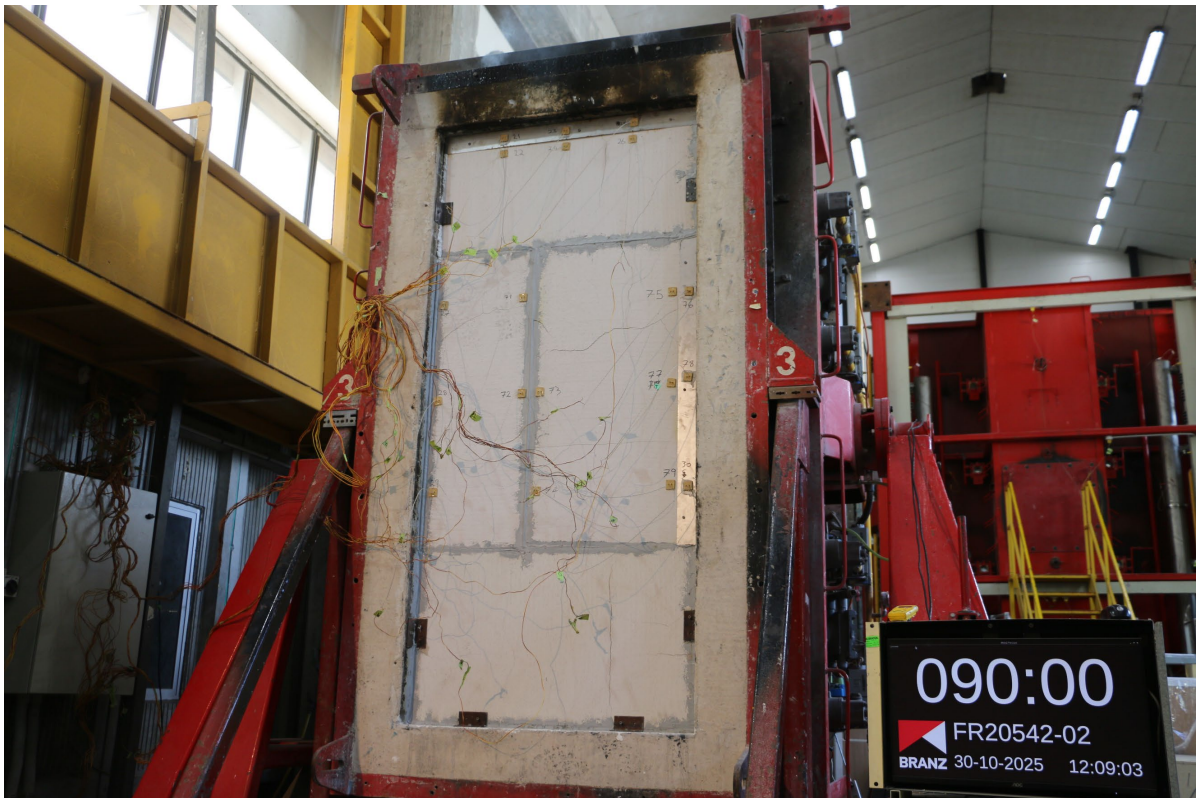
Photo 4: The Unexposed Face of the Test Assembly After a Duration of 90 Minutes

| Time (Min:Sec) | Test Face | Observations |
|---|---|---|
| 68:00 | U | Further cracking of Hebel panels, a vertical crack from between TC24 & TC26, running down to the non-specimen butt joint. |
| 90:00 | - | The specimens continue to maintain Integrity. |

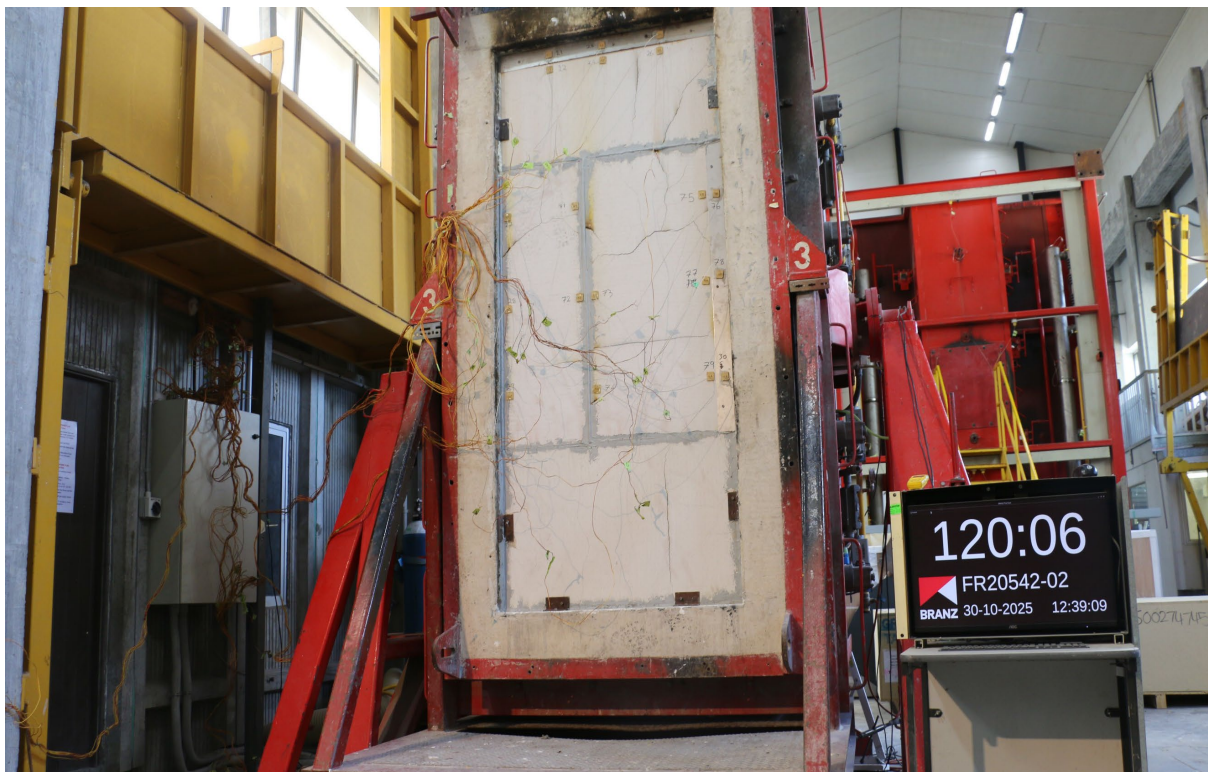
**Photo 5: The Unexposed Face of the Test Assembly After a Duration of 120 Minutes**

| Time (Min:Sec) | Test Face | Observations |
|---|---|---|
| 121:15 | - | The specimens continue to maintain Integrity, the test is discontinued. |

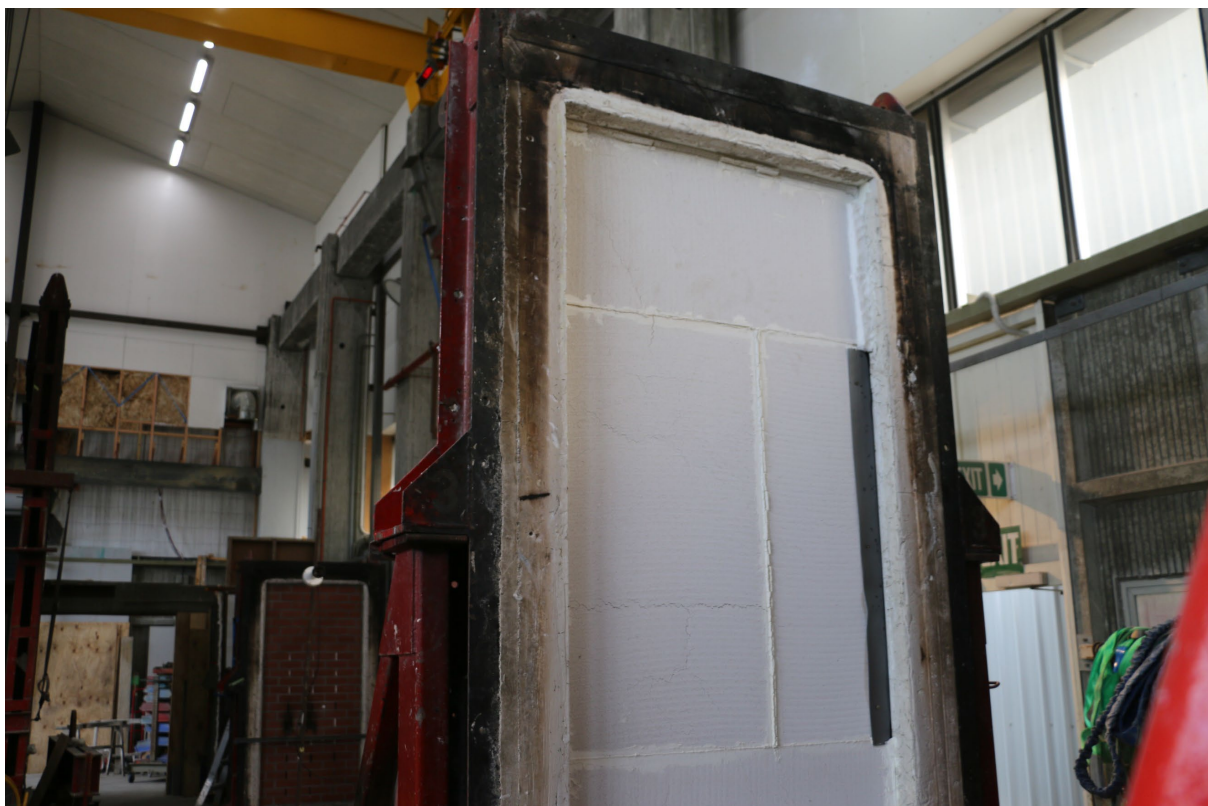
**Photo 6: The Exposed Face of the Test Assembly Immediately After Testing**
