# FIRE TEST REPORT

## FR21125-01-1

**THE FIRE RESISTANCE IN ACCORDANCE WITH  
AS 1530.4:2014 OF SIX PERIMETER EDGE SEALS  
INSTALLED IN A STEEL STUD PLASTERBOARD LINED  
WALL**

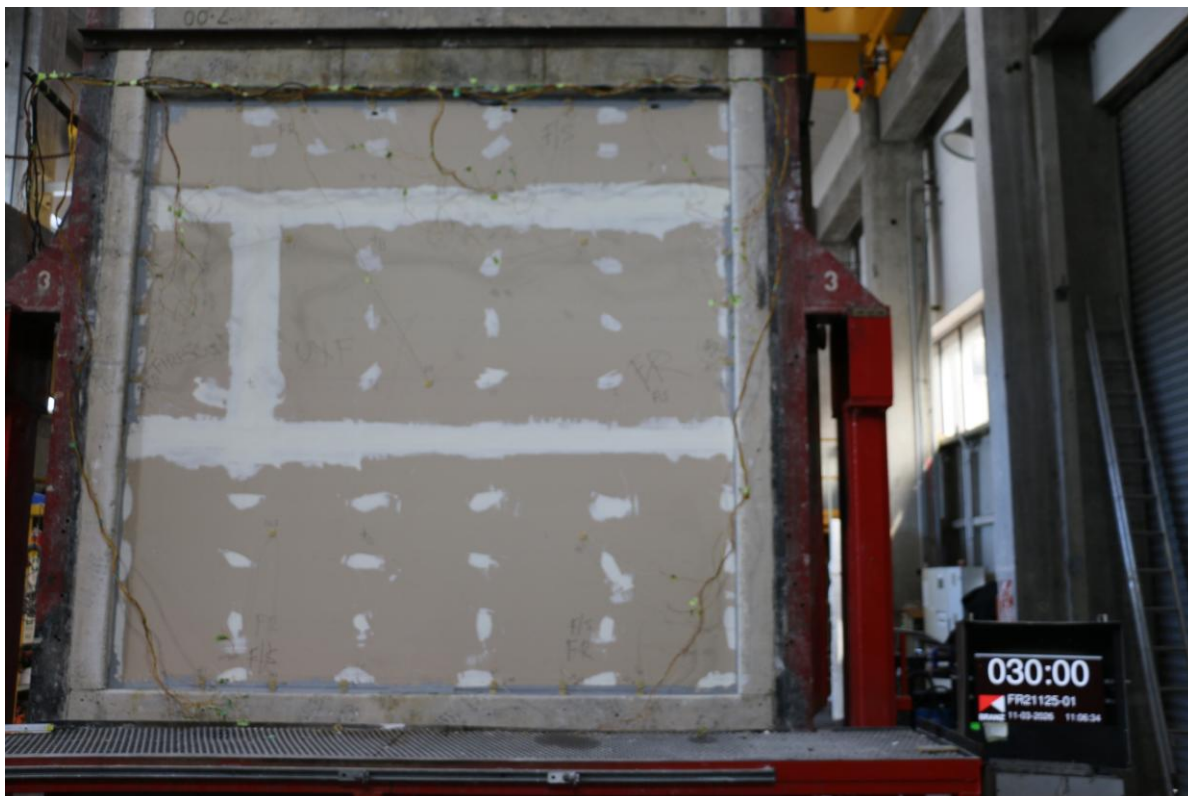
**Photo 2: The Unexposed Face of the Test Assembly After a Duration of 30 Minutes**

| <b>Time<br/>(Min:Sec)</b> | <b>Test<br/>Face</b> | <b>Observations</b> |
|---|---|---|
| 30:00 | U | The wall is deflecting towards the furnace, the sealant in the base horizontal seal Specimen F has started to split from the plasterboard edge as the bottom track has moved. |

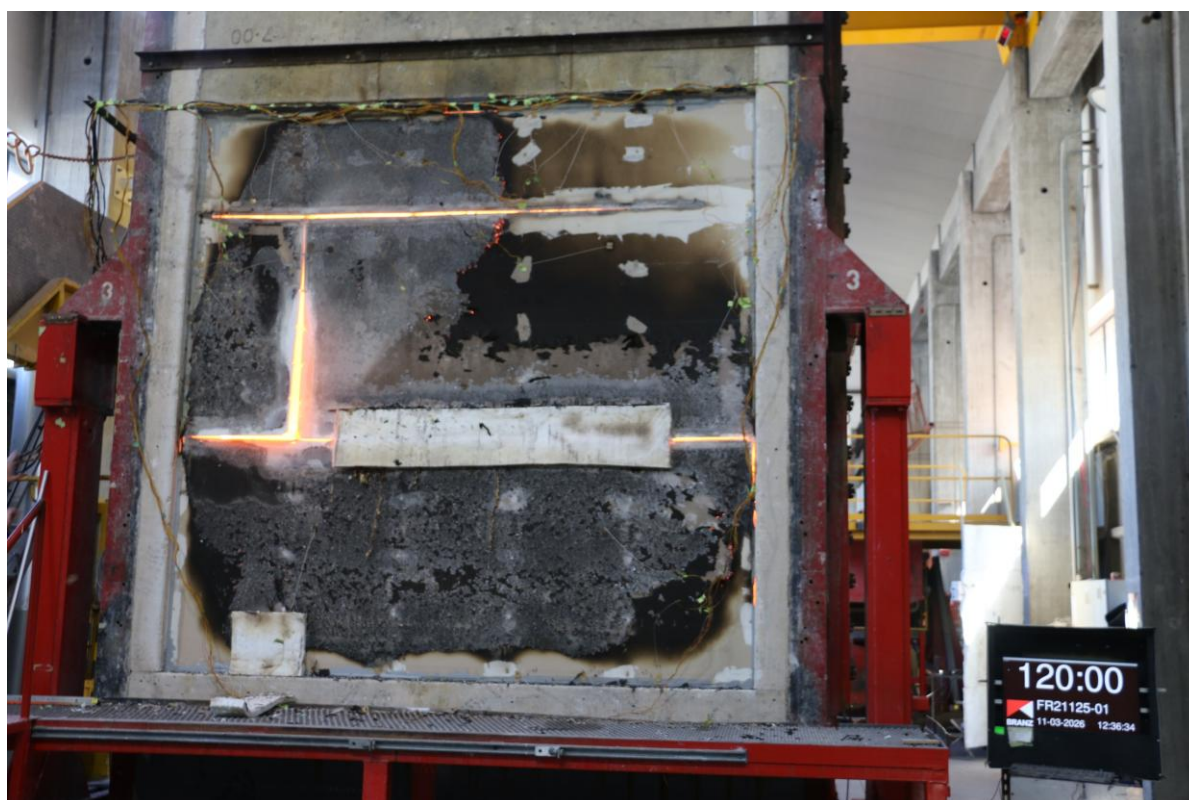
**Photo 5: The Unexposed Face of the Test Assembly After a Duration of 120 Minutes**
