FIRE TEST REPORT

FP18716-01-1

**THE FIRE RESISTANCE IN ACCORDANCE WITH
AS 1530.4:2014 OF THREE CONTROL JOINTS
INSTALLED IN A STEEL STUD PLASTERBOARD LINED
WALL**

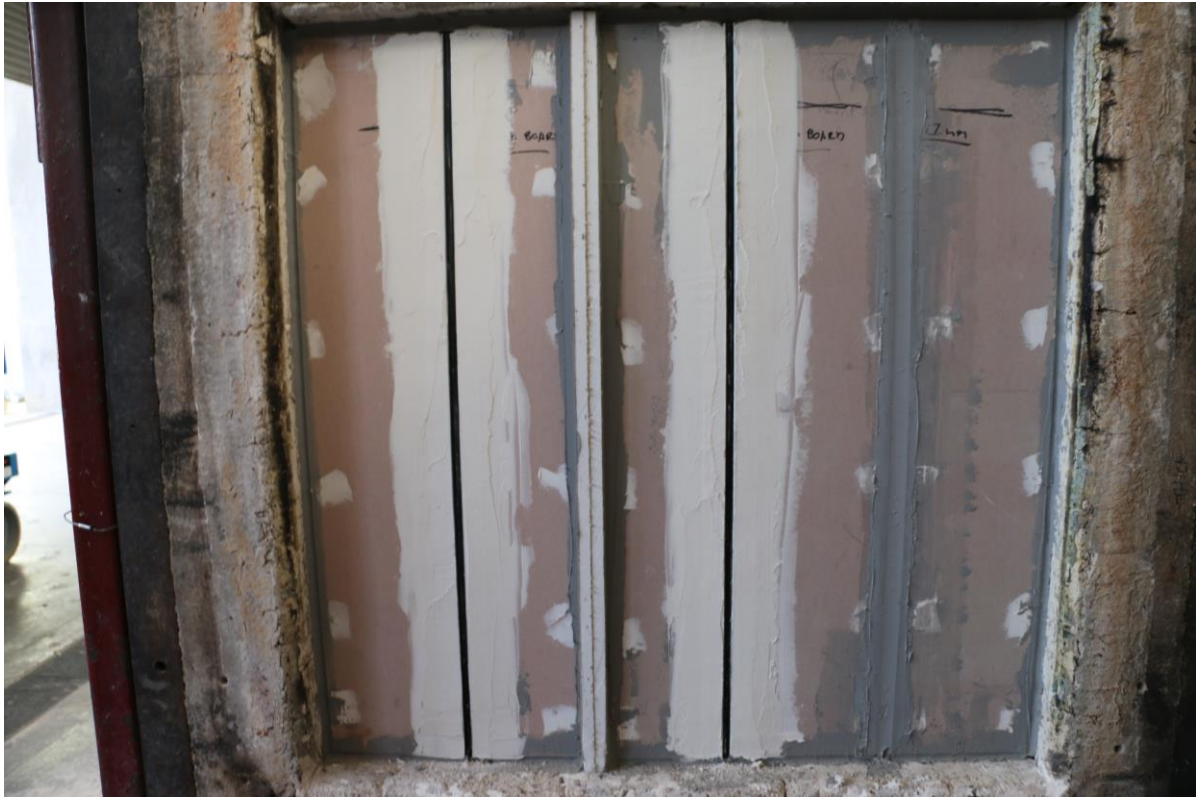
Photo 1: The Exposed Face of the Assembly Prior to Testing

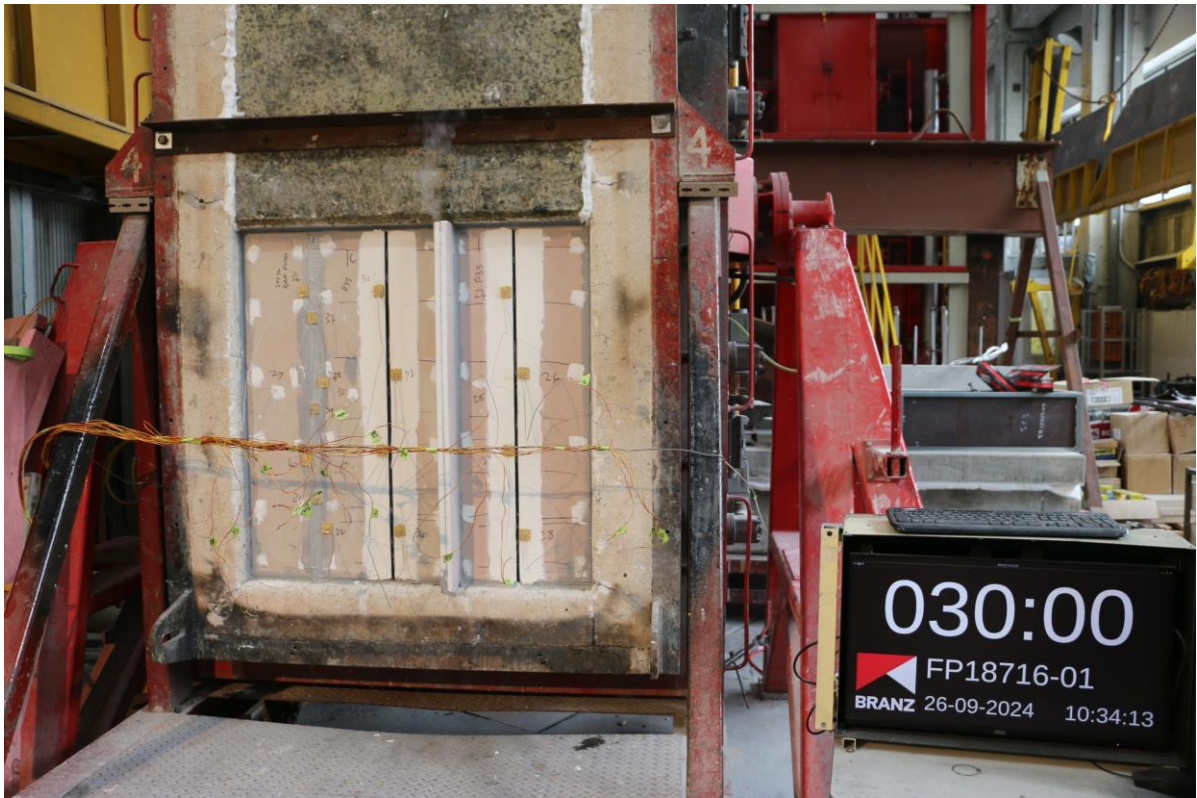
Photo 3: The Unexposed Face of the Test Assembly After a Duration of 30 Minutes

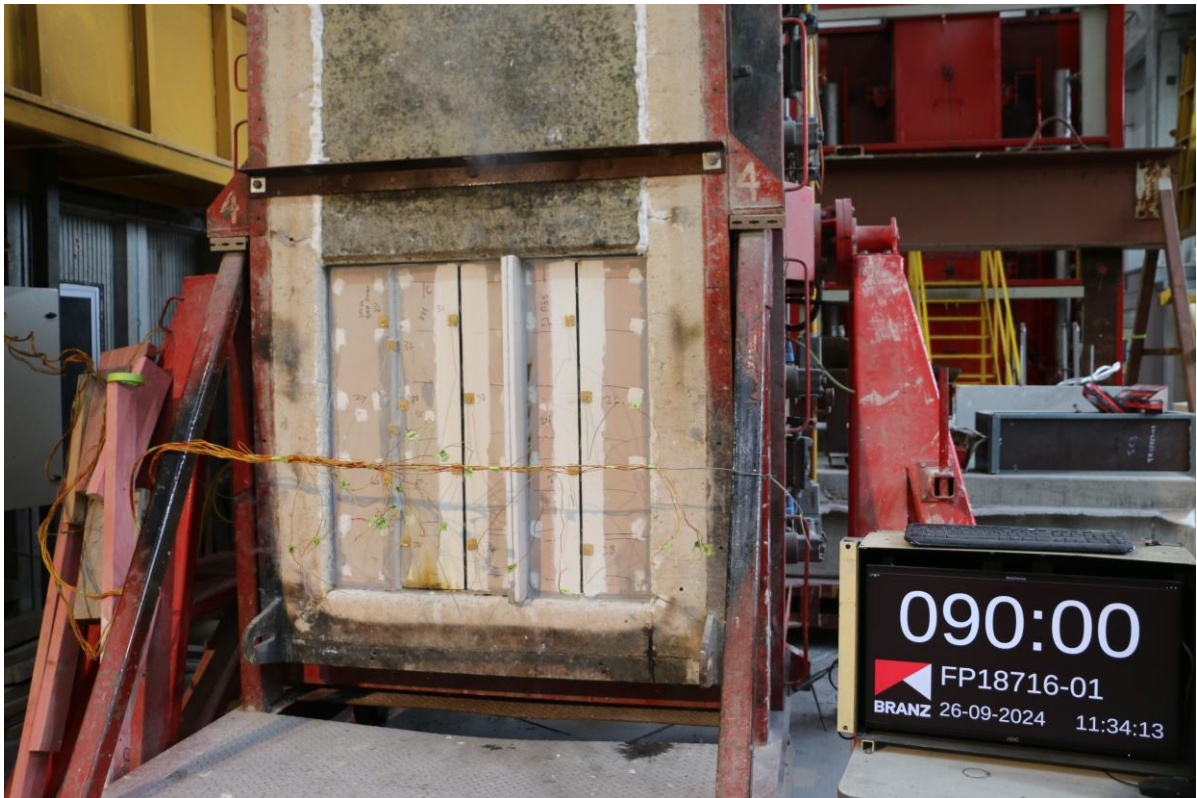
Photo 5: The Unexposed Face of the Test Assembly After a Duration of 90 Minutes

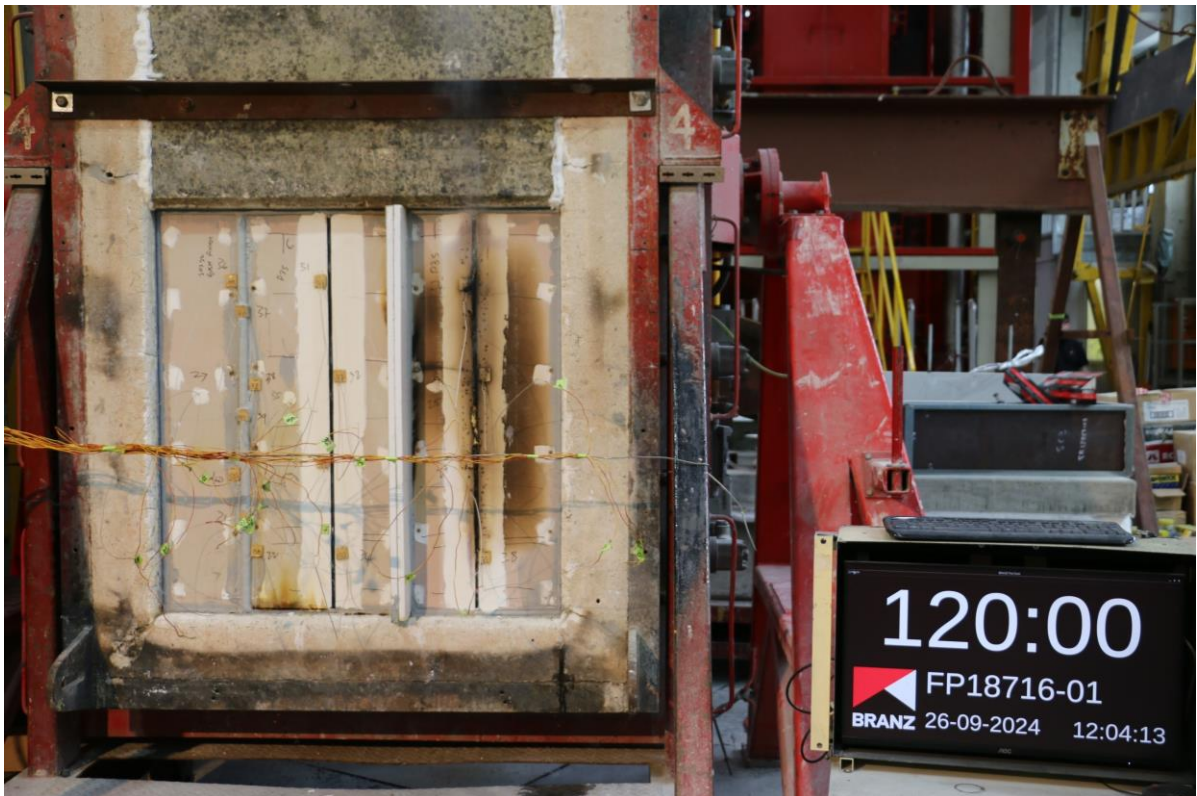
Photo 6: The Unexposed Face of the Test Assembly After a Duration of 120 Minutes

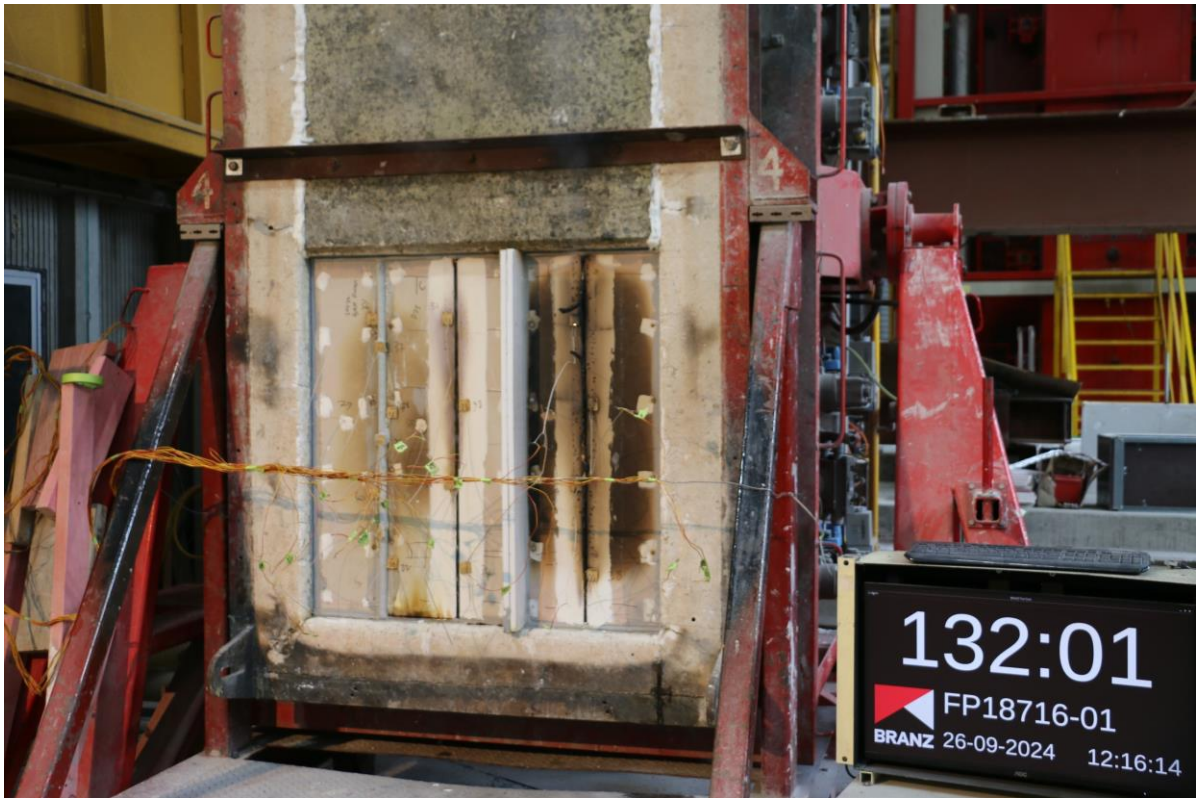
Photo 7: The Unexposed Face of the Test Assembly After a Duration of 132 Minutes

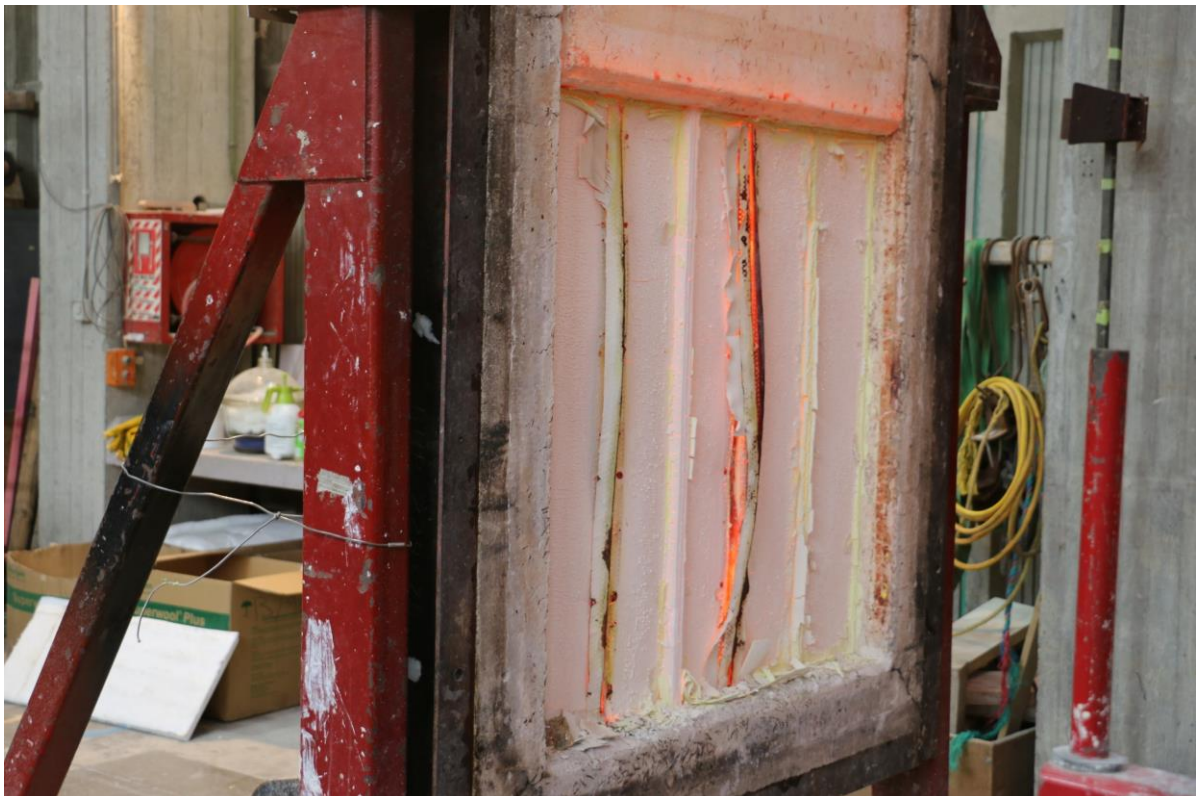
Photo 8: The Exposed Face of the Test Assembly Immediately After Testing
